IICL TB 007, 5 April 2012

Title: LIMITATIONS ON CROSSMEMBER REPAIRS

Reference IICL “Repair Manual for Steel Freight Containers (fifth edition)
Section 8.2.3 Crossmember Inserting
Section 8.4.3 Forklift Pocket Side Inserting

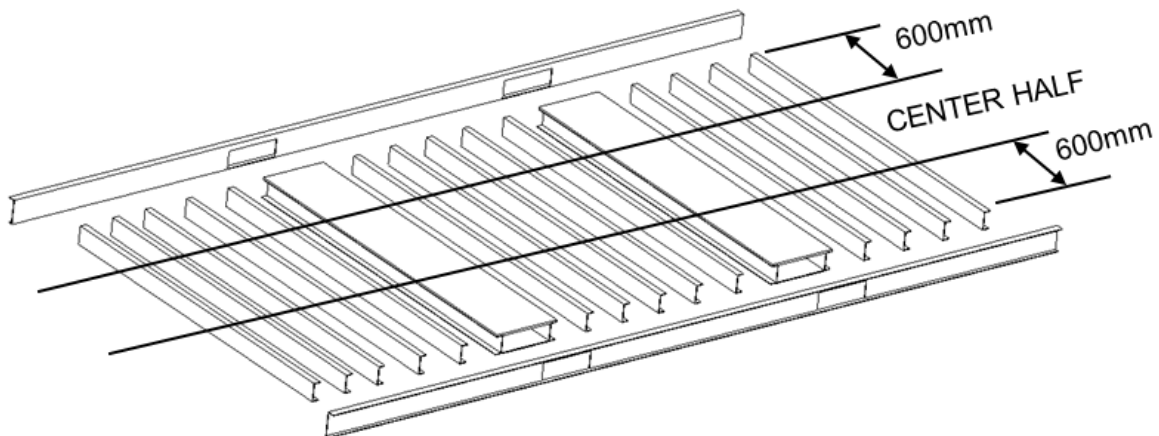
Weld repairs to members (crossmember / forklift pocket side wall) are not allowed within the center one half of two adjacent members. The center one half of a member is defined as that part of the member that is greater than 600mm from the nearest bottom side rail. If two adjacent members have weld repairs within the center halves, either one of the members must either be replaced or the inserts must be lengthened such that they do not terminate within the center half of the member.

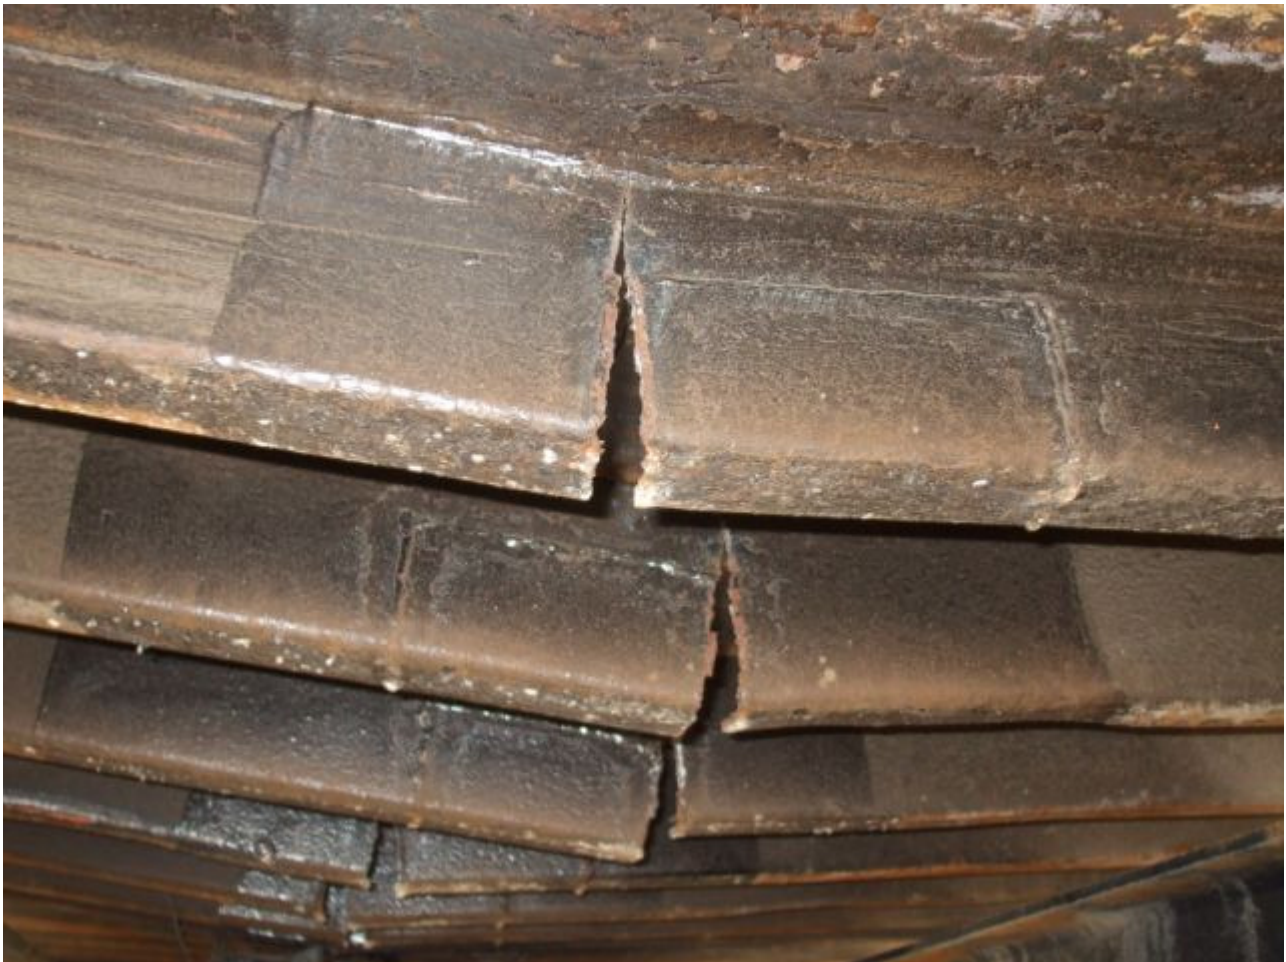
The most common repair involves the installation of a series of inserts at or near the centers of several adjacent members. The vertical welds—located near the members centers in the area of maximum bending stress and subject to the residual tension resulting from jacking the member's straight prior to installing the inserts—may have been, in a few cases, below IICL standards.

If the sub standard weld pulls apart, the floor load is passed to the adjacent member, and the adjacent insert welds may also pull apart, resulting in a series of weld failures until all inserted members have pulled apart.

With the objective of eliminating these shortcomings, the IICL Technical Committee has revised member repair standards so as to eliminate sub-standard inserting and other welded repairs in the highly stressed center portions of members.

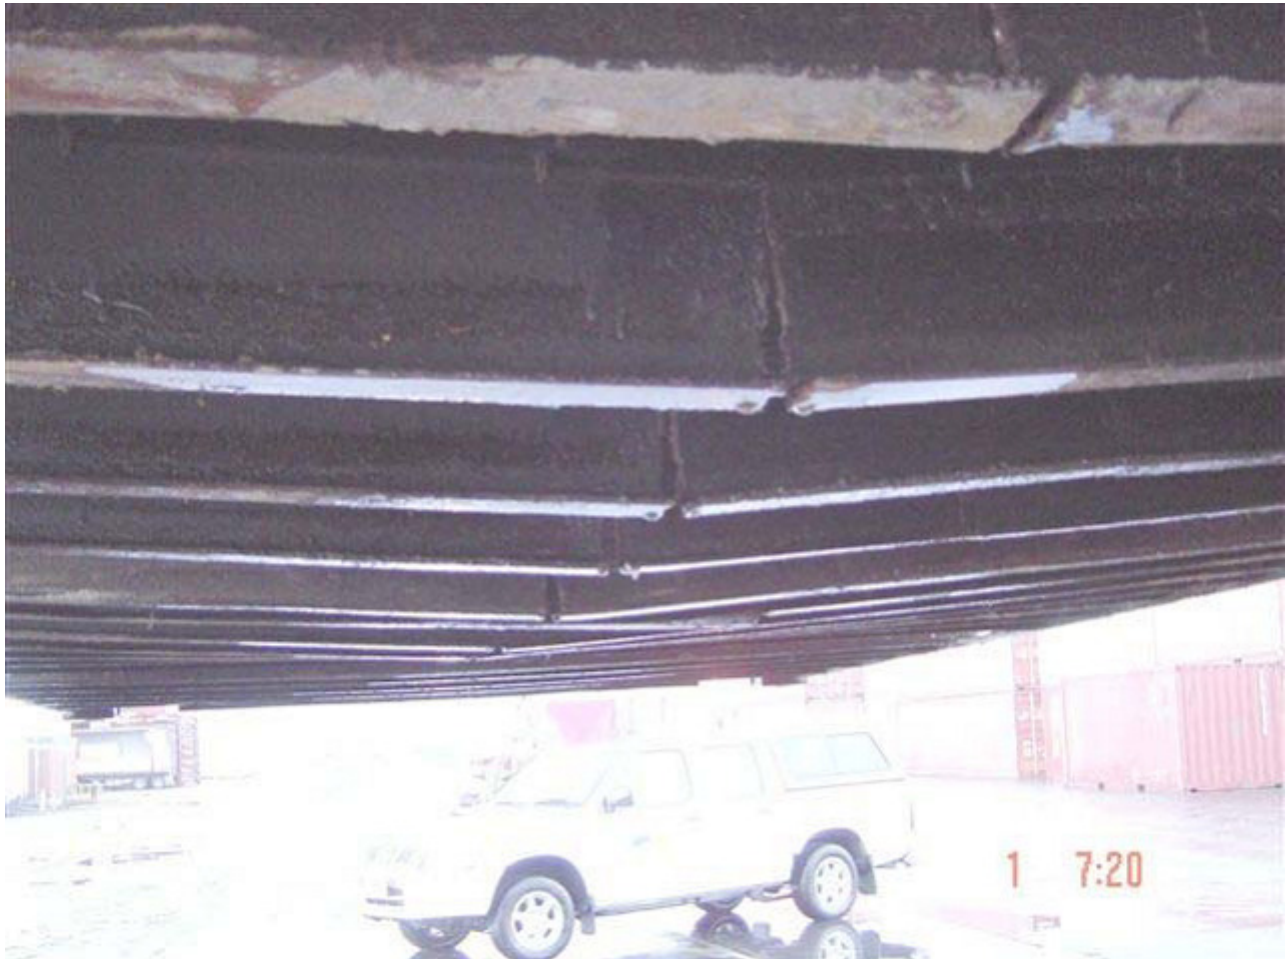
A second, but less common, repair involves cutting relief notches at or near the members centers, jacking the members straight, and weld the notch closed. These also may come apart for the same reasons and in the manner as described above.

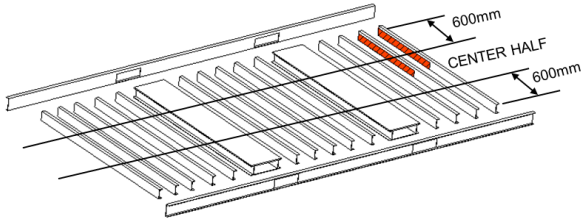
NOT ACCEPTABLE

The insert on the right side is acceptable because it is the 1st crossmember with an insert. But the 2nd insert on the left is not acceptable because the weld seam terminates in the center half of the container.

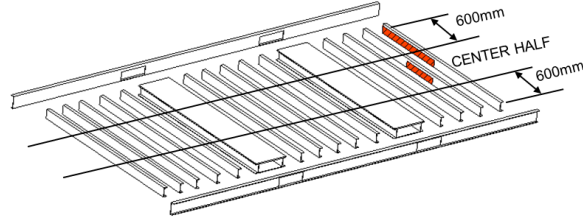
NOT ACCEPTABLE

The insert on the right side is acceptable because it is the 1st crossmember with an insert. The 2nd insert on the left is not acceptable because the weld seams terminate in the center half of the container.

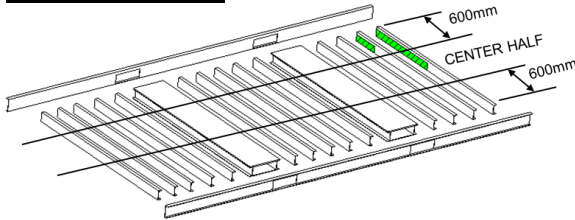
ACCEPTABLE

The insert on the right side is acceptable because it is the 1st crossmember with an insert. The 2nd insert on the left is also acceptable because the weld seams terminate within 600mm from the bottom side rail.

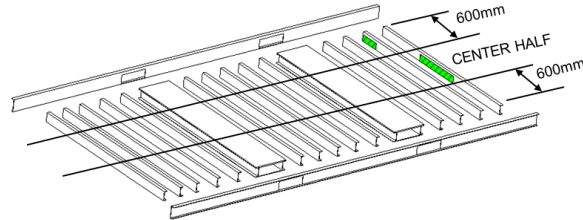
ACCEPTABLE

The insert on the right side is acceptable because it is the 1st crossmember with an insert. The 2nd insert on the left is also acceptable because the weld seams terminate within 600mm from the bottom side rail.

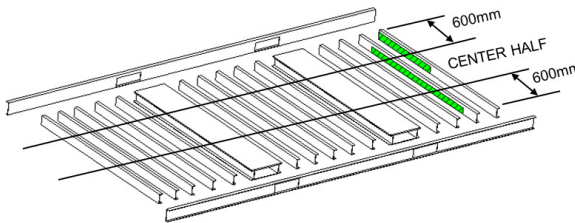
ACCEPTABLE

The insert on the right side is acceptable because it is the 1st crossmember with an insert. The 2nd insert on the left is also acceptable because the weld seams terminate within 600mm from the bottom side rails.

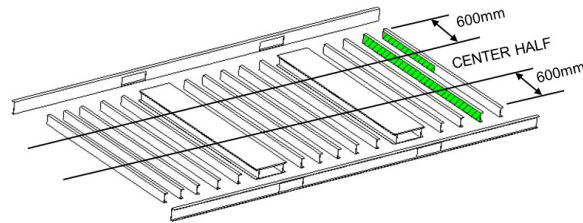
ACCEPTABLE

The insert on the right side is acceptable because it is the 1st crossmember with an insert. The 2nd cross member is also acceptable because it is actually a full replacement.

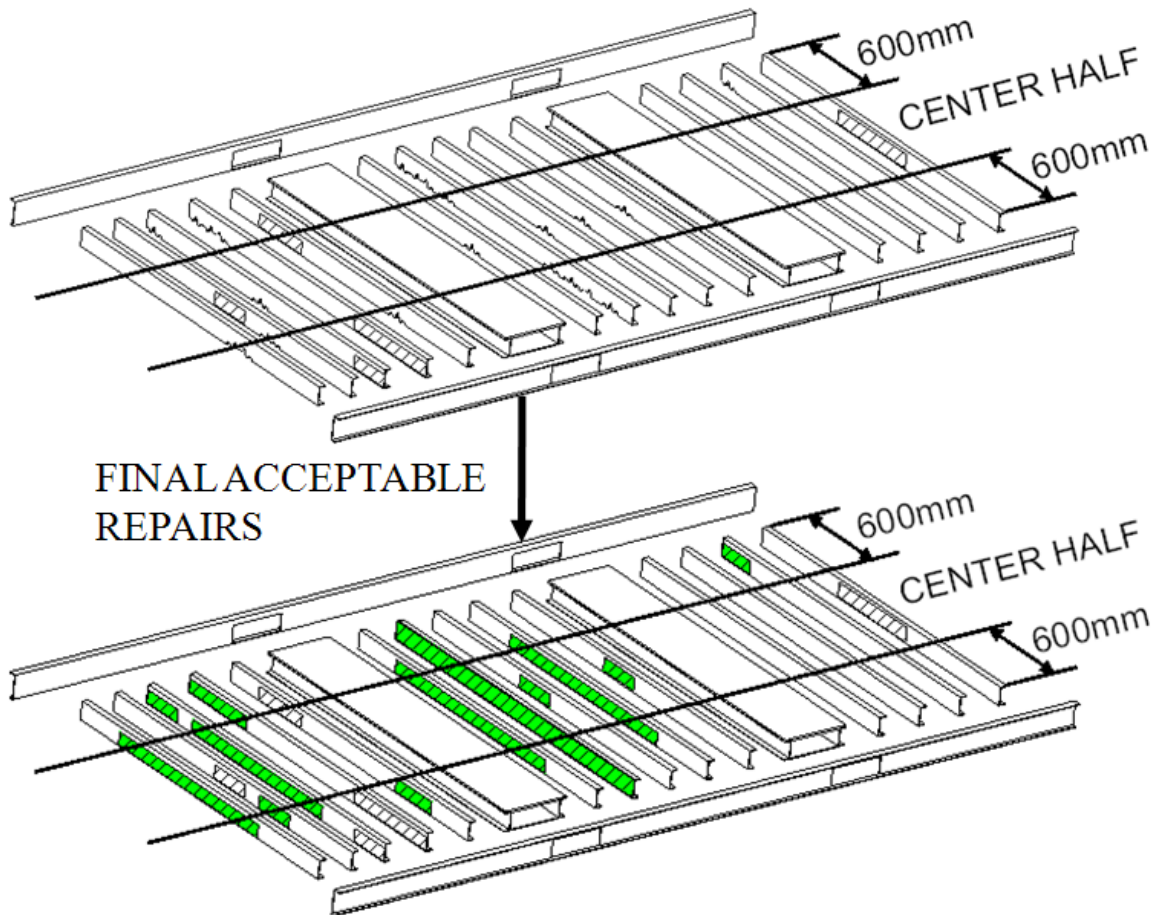
AN EXAMPLE of new damage locations and pre-existing inserts.

Acceptable inserts based on new damage locations and pre-existing inserts, as shown above. It is important to note that this is one EXAMPLE of a possible combination of damage and acceptable repair inserts. There may be many different possibilities. This drawing should only be used as a guide to determine the safest and most economical type of repair on a case by case basis.
