IICL Technical Bulletin - FTB-016

Title: Inspection & Repair limitations on understructure components

Reference: Amendment to the IICL Guide for Flatrack Container Inspection and; addendum to the IICL Guide for Flatrack Container Repair.

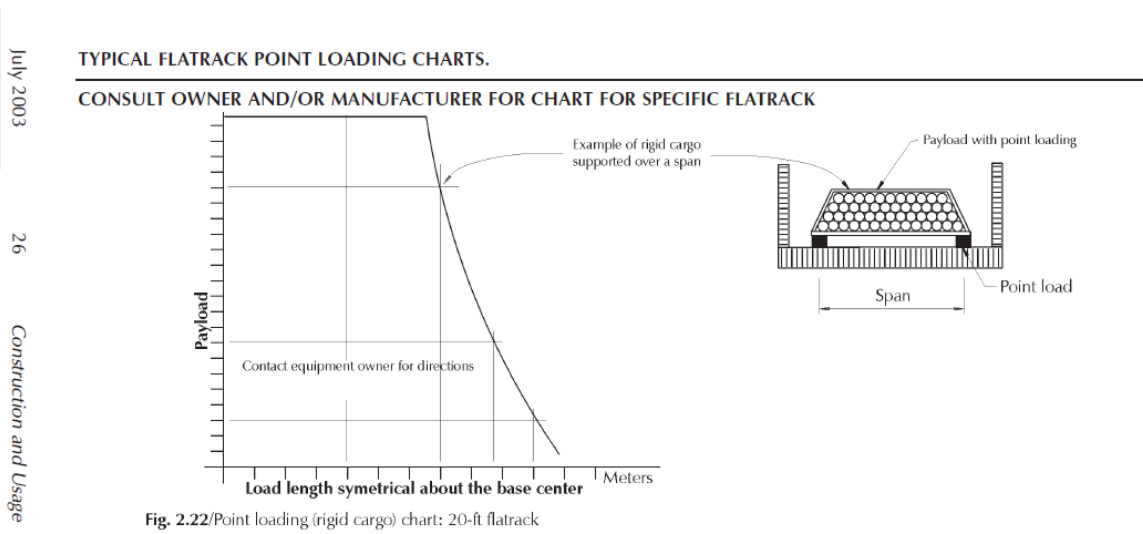
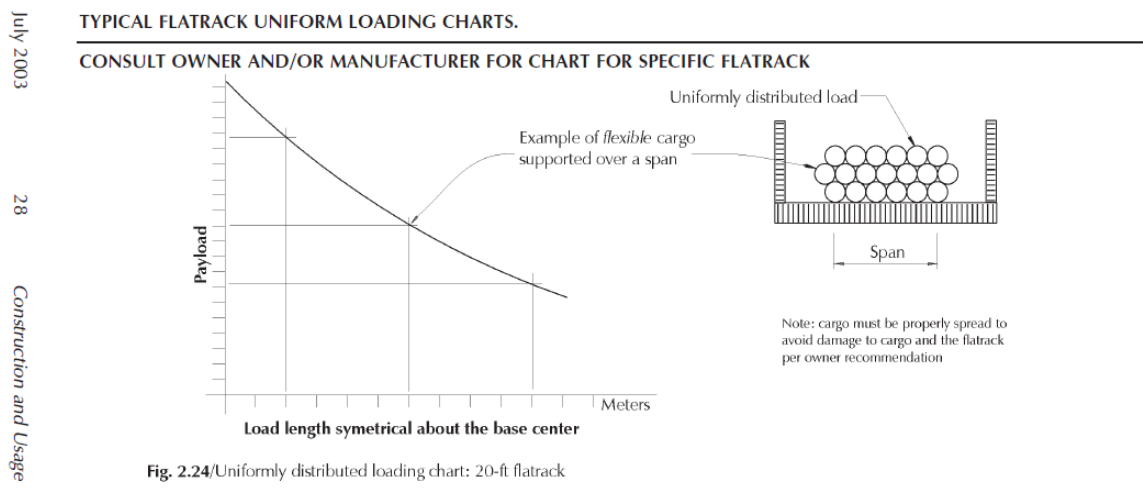
Vertical bowing down of understructure components can occur for various reasons, cargo overloading, improper weight distribution, impact damage, etc. Cargo overloading and improper weight distribution are exacerbated during normal container lifting operations and at sea when the structure is submitted to gravitational forces (g-force), typically acceleration and deceleration. The IICL Guide for Flatrack Container Inspection provides guidance on how to properly load Flatrack containers and distribute the load however, due to a variety of Flatrack designs it is recommended that users consult the owner or manufacturer if in doubt.

Understructure components that are bowed down, typically crossmembers and forklift pocket components, less frequently bottom rails, gooseneck tunnel bolster and rails, have exceeded their material structural yield point when the IICL limits are exceeded. The yield point is the point on a stress-strain curve that indicates the limit of elastic behavior and the beginning of plastic behavior. The material has stretched and entered the plastic behavior where deformations are permanent. Once the material has entered the plastic behavior it is no longer possible to reverse the process or “shrink” the deformation through straightening using heat or not, vertical cutting notches or inserts. The material strength and ability to withstand future loads is then compromised.

The IICL repair recommendation is that bowed down webs of understructure components, exceeding IICL tolerances, shall be repaired through:

- *Full Replacement.*

Note: Cutting relief notches for straightening of understructure components or straightening bowed down understructure whether using heat or not, straightening and/or inserting bowed down components are considered non-conforming repair methods.

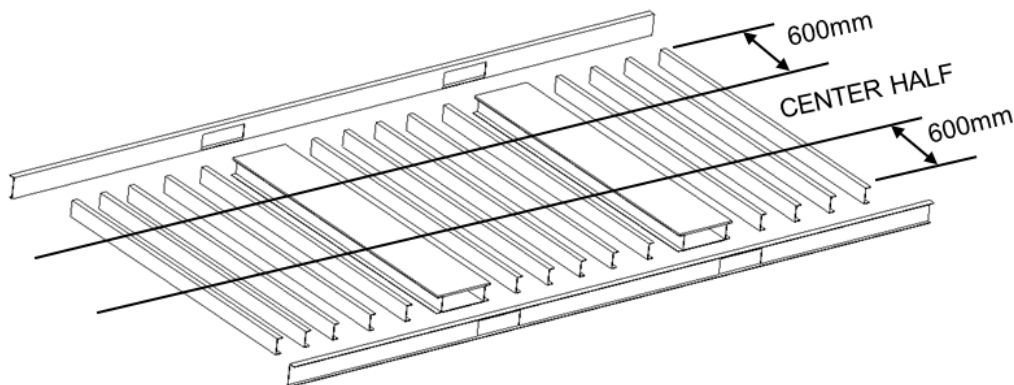
NOT ACCEPTABLE

Weld repairs to members (crossmember / forklift pocket side wall) are not allowed within the center one half of two adjacent members. The center one half of a member is defined as that part of the member that is greater than 600mm from the nearest bottom side rail. If two adjacent members have weld repairs within the center halves, either one of the members must either be replaced or the inserts must be lengthened such that they do not terminate within the center half of the member.

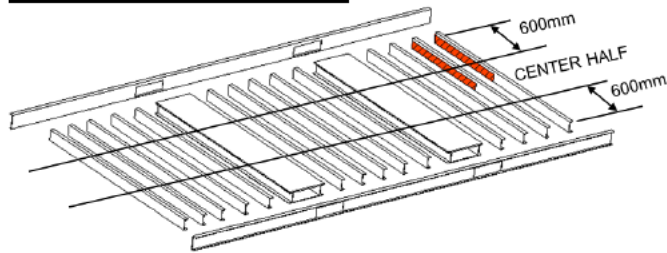
NOT ACCEPTABLE

The insert on the right side is acceptable because it is the 1st crossmember with an insert. But the 2nd insert on the left is not acceptable because the weld seam terminates in the center half of the container.

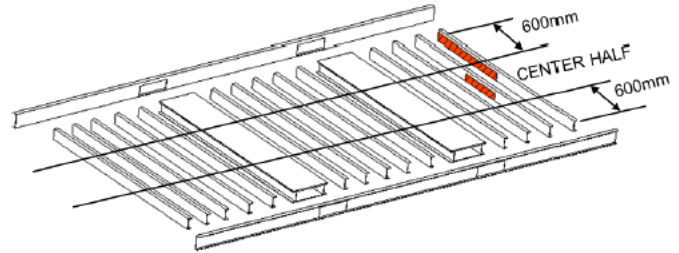
NOT ACCEPTABLE

The insert on the right side is acceptable because it is the 1st crossmember with an insert. The 2nd insert on the left is not acceptable because the weld seams terminate in the center half of the container.

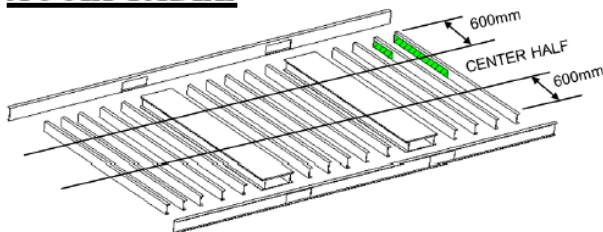
ACCEPTABLE

The insert on the right side is acceptable because it is the 1st crossmember with an insert. The 2nd insert on the left is also acceptable because the weld seams terminate within 600mm from the bottom side rail.

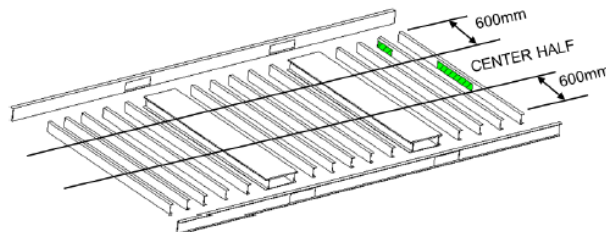
ACCEPTABLE

The insert on the right side is acceptable because it is the 1st crossmember with an insert. The 2nd insert on the left is also acceptable because the weld seams terminate within 600mm from the bottom side rail.

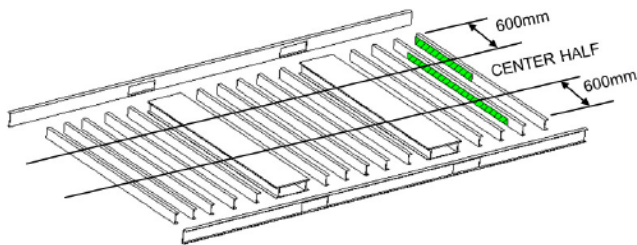
ACCEPTABLE

The insert on the right side is acceptable because it is the 1st crossmember with an insert. The 2nd insert on the left is also acceptable because the weld seams terminate within 600mm from the bottom side rails.

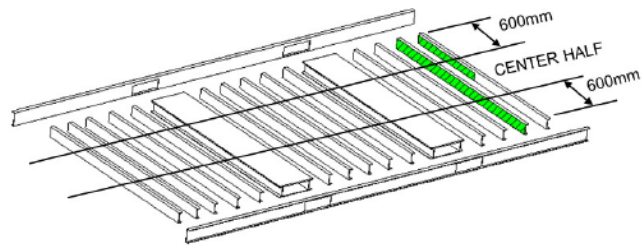
ACCEPTABLE

The insert on the right side is acceptable because it is the 1st crossmember with an insert. The 2nd cross member is also acceptable because it is actually a full replacement.

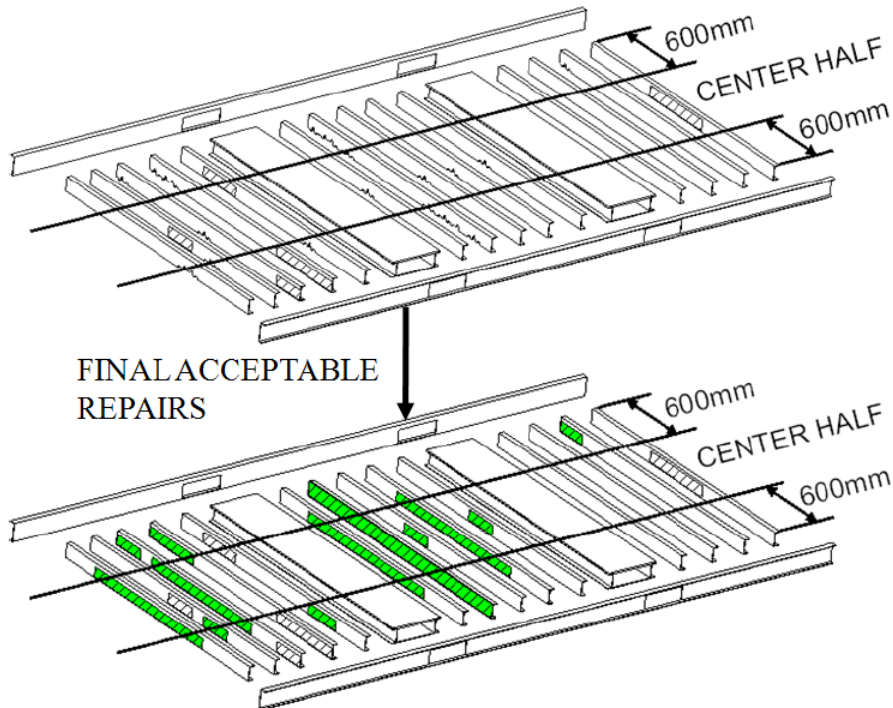
FULL CONTAINER EXAMPLE

AN EXAMPLE of new damage locations and pre-existing inserts.

Acceptable inserts based on new damage locations and pre-existing inserts, as shown above. It is important to note that this is one EXAMPLE of a possible combination of damage and acceptable repair inserts. There may be many different possibilities. This drawing should only be used as a guide to determine the safest and most economical type of repair on a case-by-case basis.
