## IICL Technical Bulletin - TB-021-Rev: 7 July 2026 (Revised 7 July 2026)

**Title:** Repair limitations on understructure components

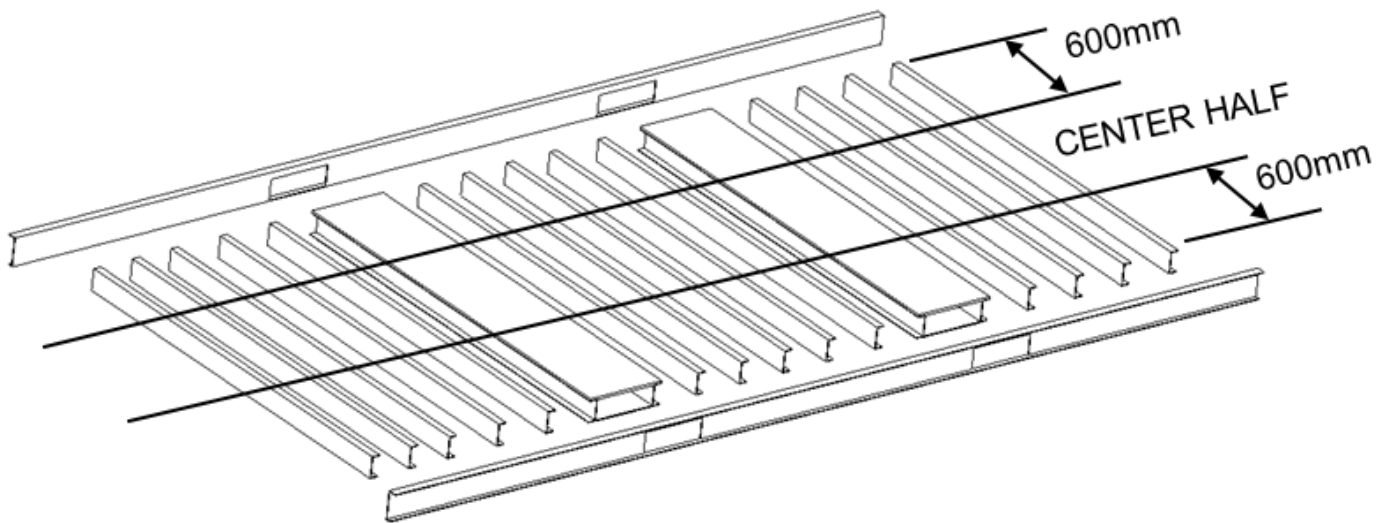
## NOT ACCEPTABLE

Weld repairs to members (crossmember / forklift pocket side wall) are not allowed within the center one half of two adjacent members. The center one half of a member is defined as that part of the member that is greater than 600mm from the nearest bottom side rail. If two adjacent members have weld repairs within the center halves, either one of the members must either be replaced or the inserts must be lengthened such that they do not terminate within the center half of the member.

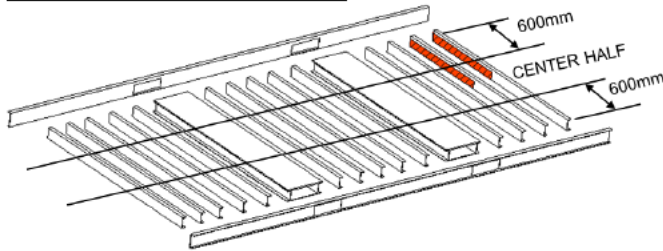
### NOT ACCEPTABLE

The insert on the right side is acceptable because it is the 1<sup>st</sup> crossmember with an insert. But the 2<sup>nd</sup> insert on the left is not acceptable because the weld seam terminates in the center half of the container.

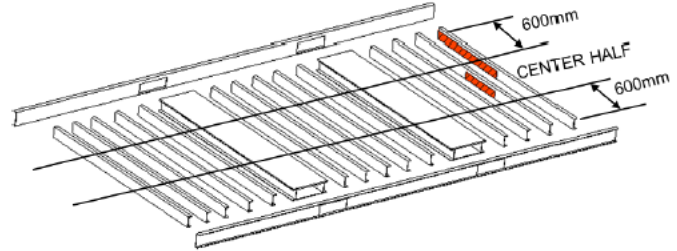
### NOT ACCEPTABLE

The insert on the right side is acceptable because it is the 1<sup>st</sup> crossmember with an insert. The 2<sup>nd</sup> insert on the left is not acceptable because the weld seams terminate in the center half of the container.

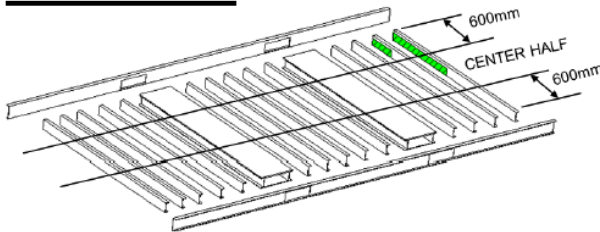
### ACCEPTABLE

The insert on the right side is acceptable because it is the 1<sup>st</sup> crossmember with an insert. The 2<sup>nd</sup> insert on the left is also acceptable because the weld seams terminate within 600mm from the bottom side rail.

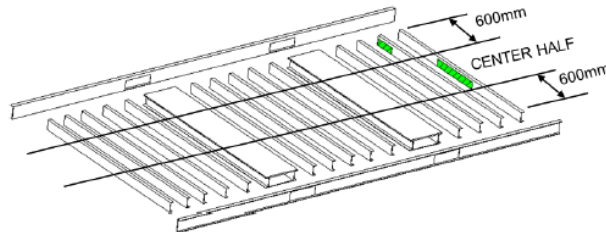
### ACCEPTABLE

The insert on the right side is acceptable because it is the 1<sup>st</sup> crossmember with an insert. The 2<sup>nd</sup> insert on the left is also acceptable because the weld seams terminate within 600mm from the bottom side rail.

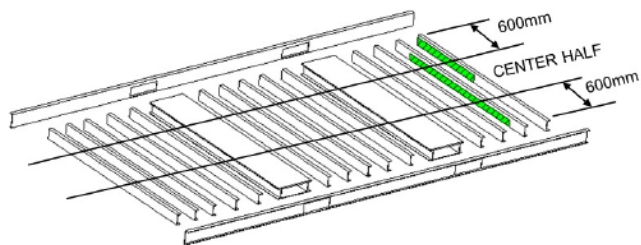
**ACCEPTABLE**

The insert on the right side is acceptable because it is the 1<sup>st</sup> crossmember with an insert. The 2<sup>nd</sup> insert on the left is also acceptable because the weld seams terminate within 600mm from the bottom side rails.

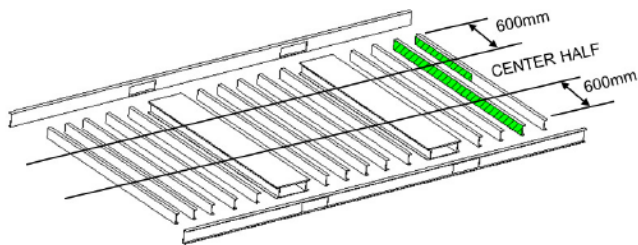
**ACCEPTABLE**

The insert on the right side is acceptable because it is the 1<sup>st</sup> crossmember with an insert. The 2<sup>nd</sup> cross member is also acceptable because it is actually a full replacement.

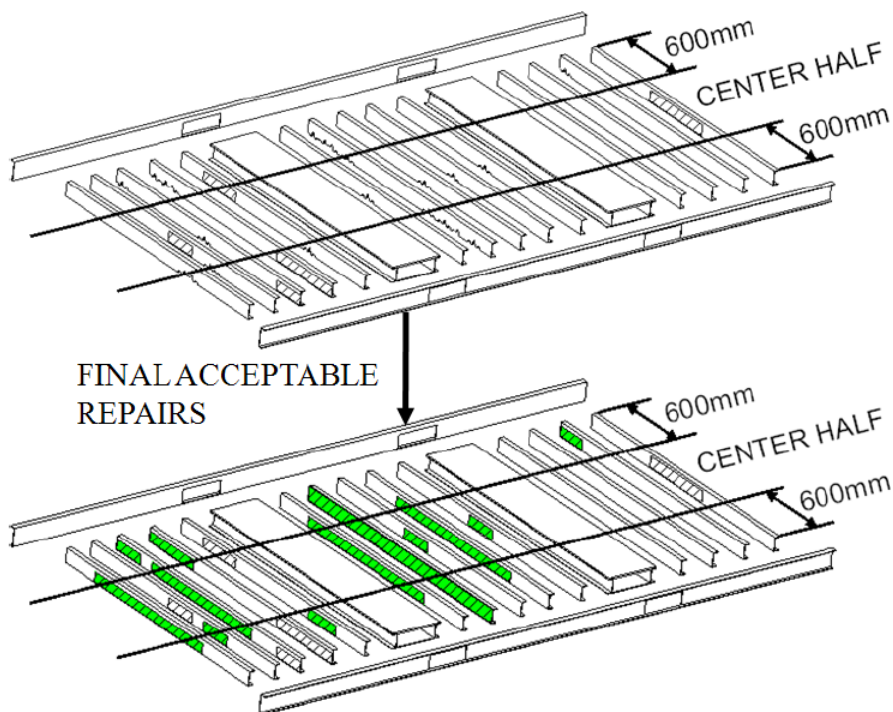
**FULL CONTAINER EXAMPLE**

AN EXAMPLE of new damage locations and pre-existing inserts.

Acceptable inserts based on new damage locations and pre-existing inserts, as shown above. It is important to note that this is one EXAMPLE of a possible combination of damage and acceptable repair inserts. There may be many different possibilities. This drawing should only be used as a guide to determine the safest and most economical type of repair on a case-by-case basis.

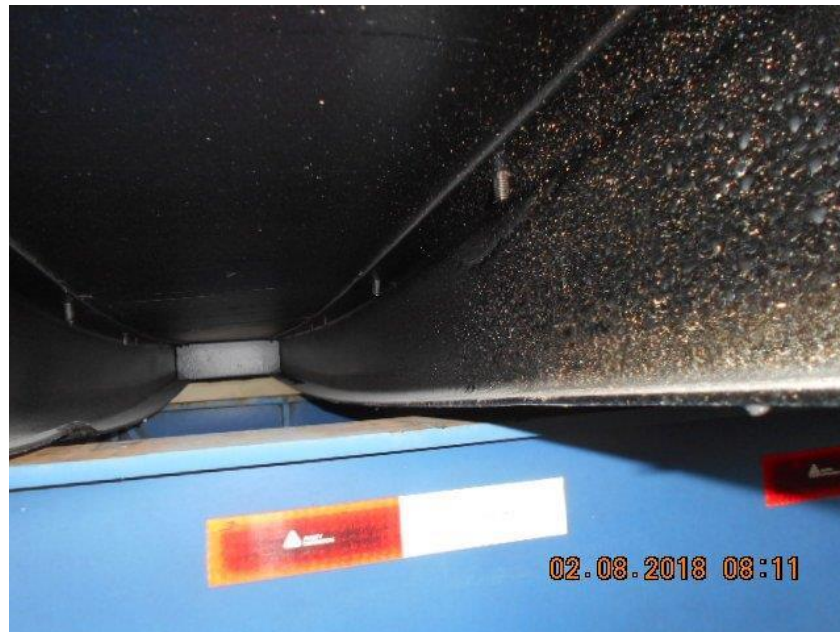
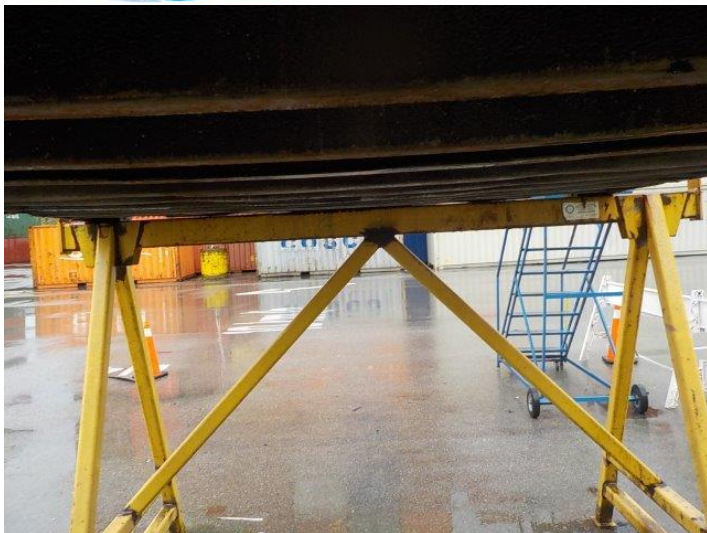
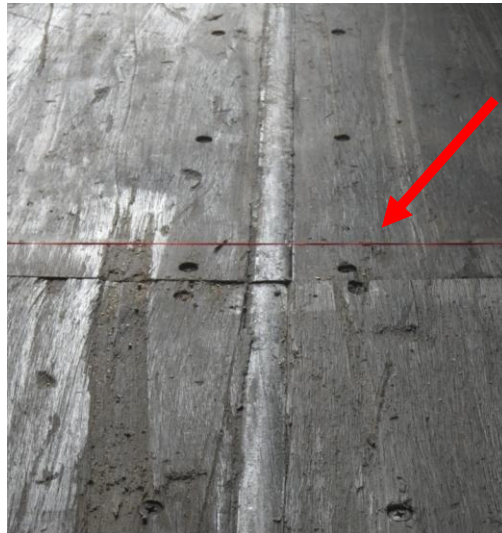
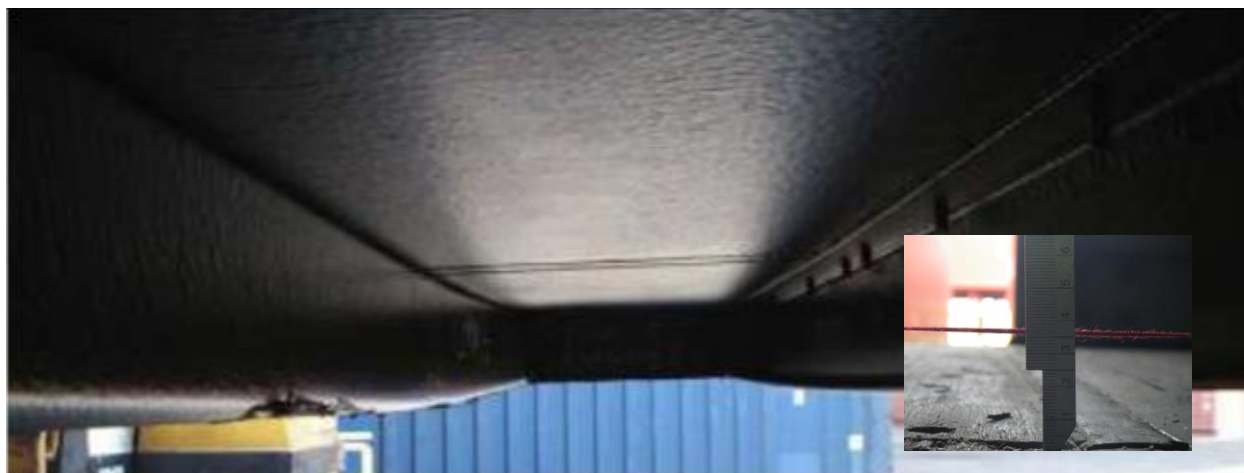
Understructure components that are bowed down, typically crossmembers and fork pocket components, less frequently bottom rails, gooseneck tunnel bolster and rails, have exceeded their material structural yield point when the IICL limits are exceeded. The yield point is the point on a stress-strain curve that indicates the limit of elastic behavior and the beginning of plastic behavior. The material has stretched and entered the plastic behavior where deformations are permanent. Once the material has entered the plastic behavior it is no longer possible to reverse the process or “shrink” the deformation through straightening using heat or not. The material strength and ability to withstand future loads is then compromised.

The following photos depict some examples of bowed down understructure components.

*The IICL repair recommendation is that bowed down understructure components, more than IICL tolerances, should be repaired through:*

- *Full Replacement*

Note: Cutting relief notches for straightening understructure components or straightening bowed down understructure components are considered non-conforming repair methods.
