## Open Top Technical Bulletin OT TB 001, July 2015 (Revised)

**Title: Open Top Container Roof Bows – Updated Criteria**

**Component: Roof Bows**

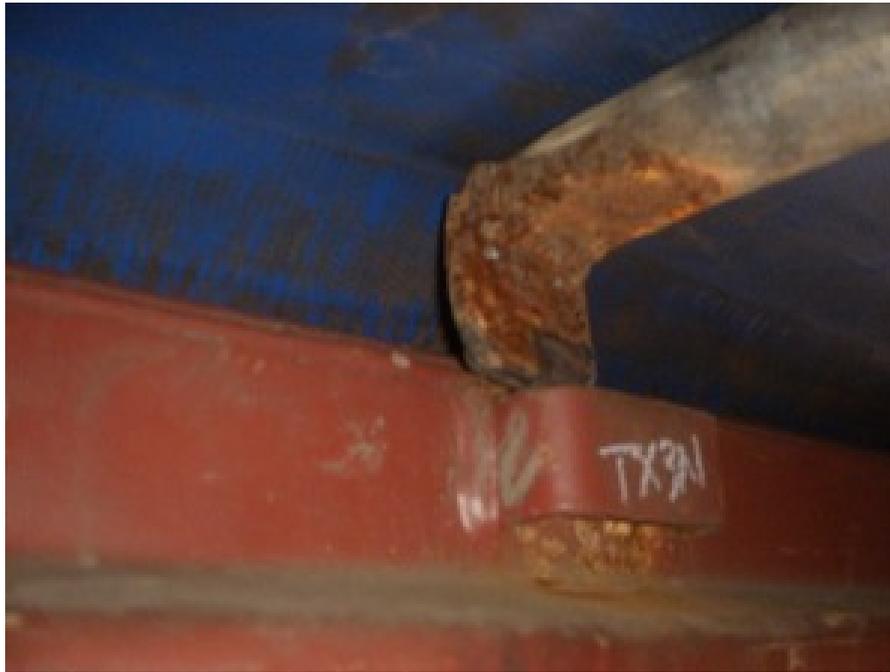
Improperly fitted roof bow end

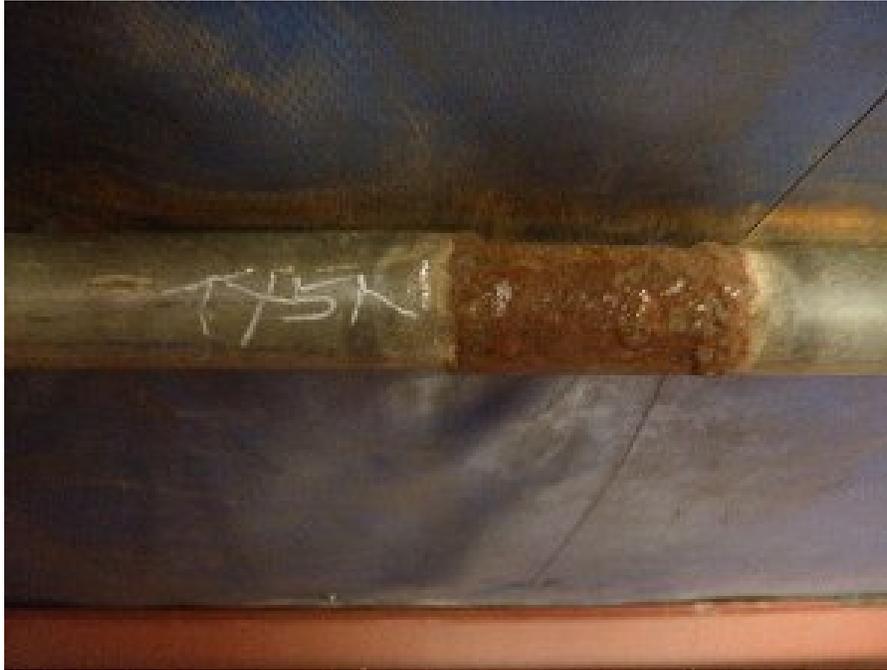
Improper Section  
Will cause tarp damage

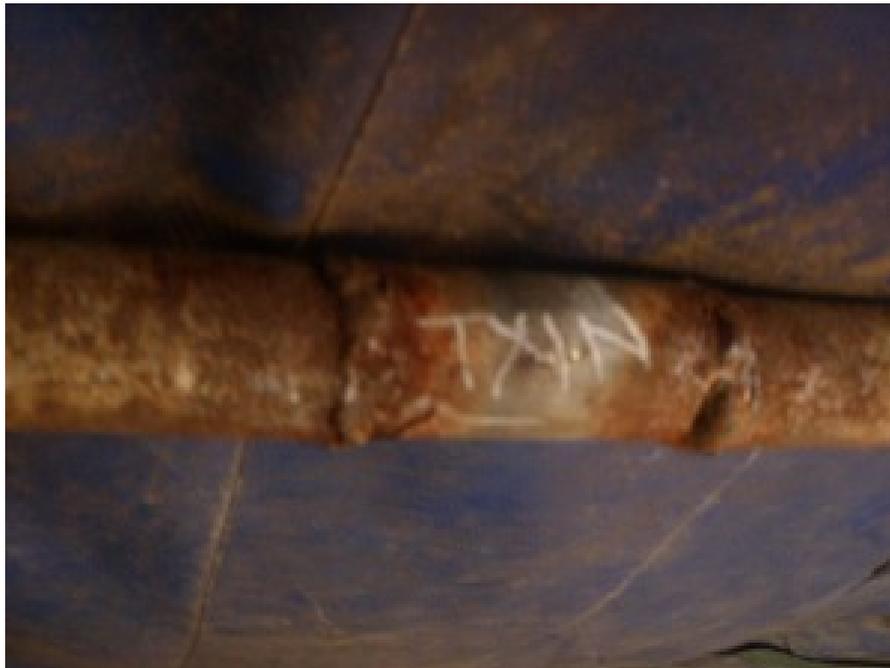
Improper section

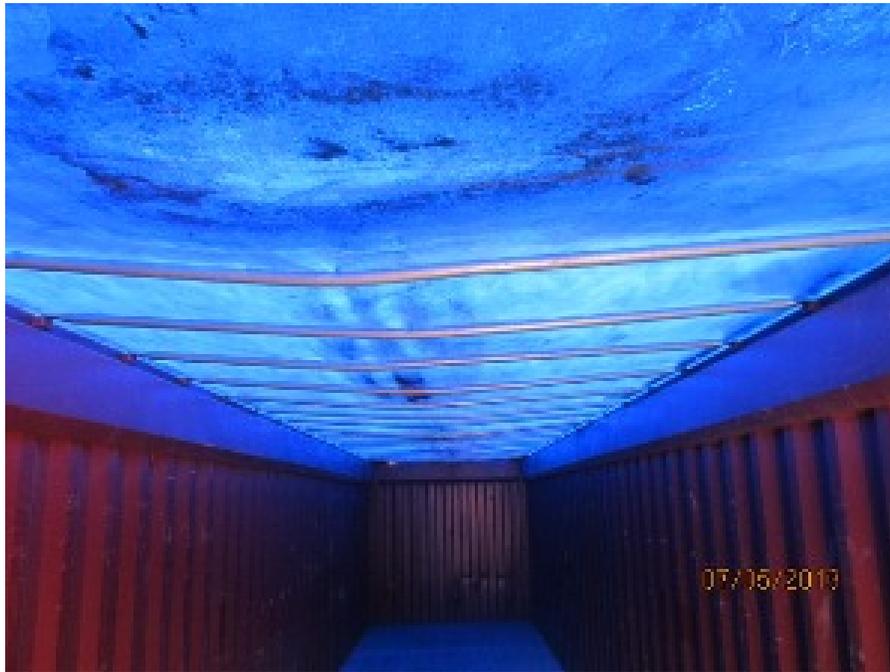
No camber

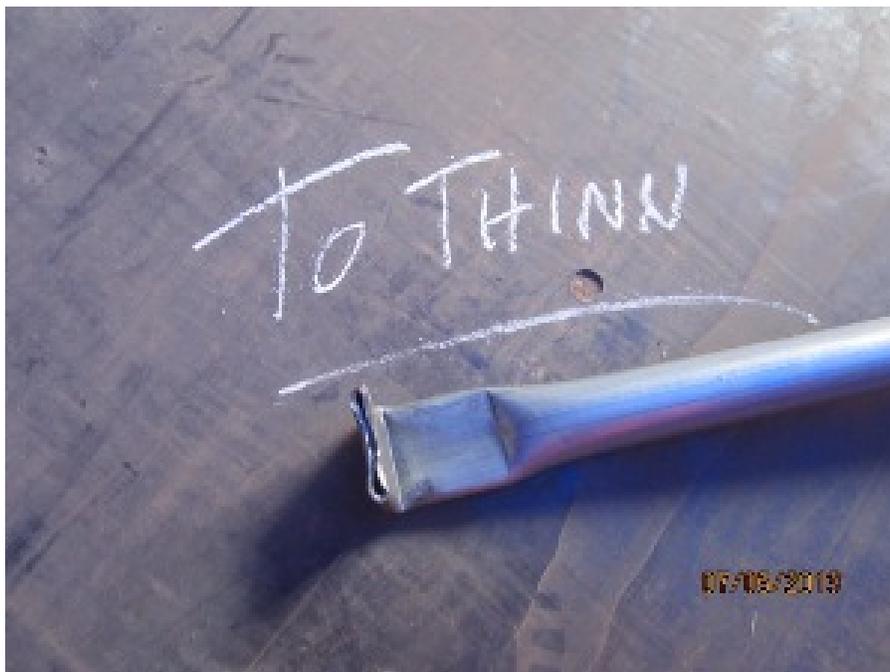
Improperly fitted roof bow

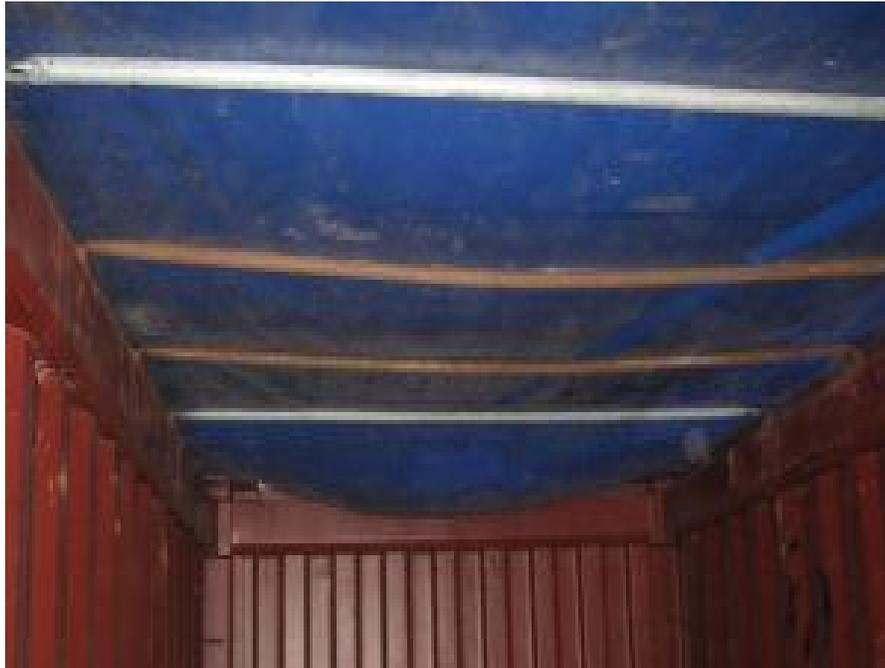
Improper bows  
Wrong material (not galvanized)  
No camber
