IICL Technical Bulletin - RTB-009 – addendum.

Background: Refrigerated containers are being disinfected in China and possibly other locations as a prevention for spreading COVID-19. The chemicals being used are damaging the stainless-steel interior panels, aluminum, and other components within the container.

Purpose: Provide inspectors with guidance on how to differentiate damage caused by contamination resulting from the spraying of chemicals in the interior of the container and recommend action to mitigate the damage being caused to internal components. **Recommended damage mitigation action is shown on page 8.**

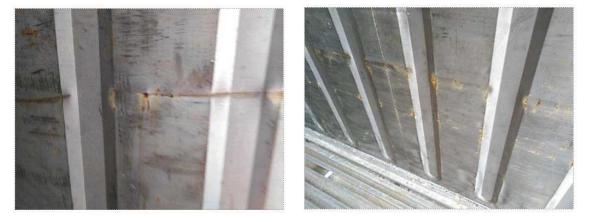
Minor rusty scratches on the HGSS panels due to loading/unloading operations, Refer to IICL General Guide for Container Cleaning, 3rd Ed.

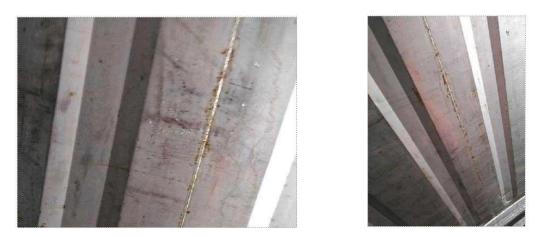
Superficial rust near the welding seam area, Refer to IICL General Guide for Container Cleaning, 3rd Ed.

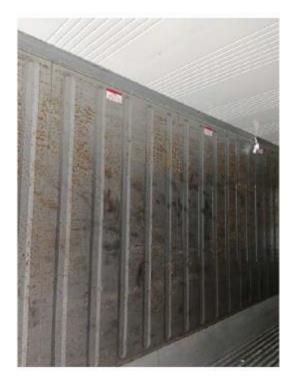
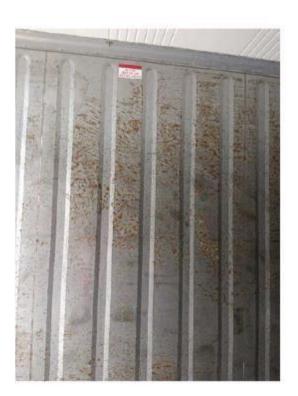
Contaminated panels showing rust/corrosion marks spread over large areas including weld seams, corrugated and flat surfaces. Above photos depict typical damage caused by contamination as result of chemical spraying. Repair required.

The IICL strongly recommends that all refrigerated containers have the interior steam cleaned or, at least, high-pressure washed as soon as cargo is devanned. The IICL recommendation is valid for all locations. Water vapor and high-pressure washing can help to dilute the chemicals applied onto the interior of the containers and <u>mitigate</u> the damaging effects by penetrating in the small crevices to reduce the chemical concentration. This practice alone <u>is not a final solution or remedy</u> to the harmful effects of the chemicals being sprayed but a practical attempt to lessen the extent of damage to the equipment. The IICL continues to research this issue.

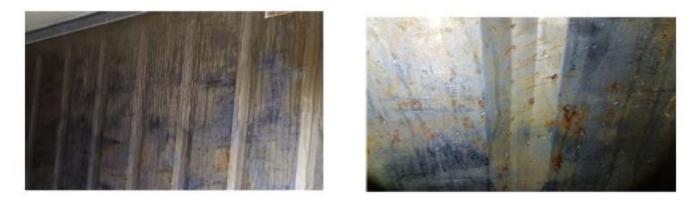
Contaminated panels showing rust/corrosion marks spread over large areas including weld seams, corrugated and flat surfaces. Above photos depict typical damage caused by contamination as result of chemical spraying. Repair required.

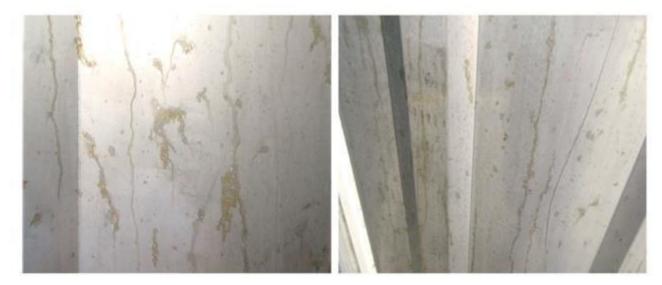
Rust/corrosion stains. Above photos depict typical damage resulting from contaminated panels after spraying with harmful chemicals. Repair required.

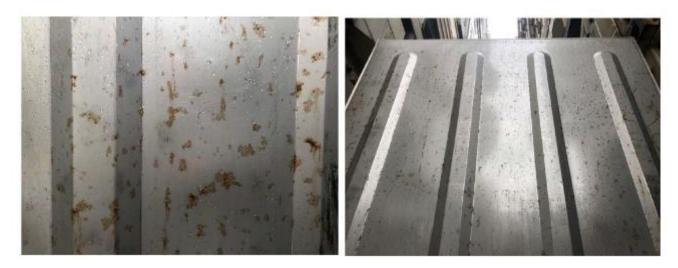
Rust/corrosion stains and pitting. Above photos depict typical damage resulting from contaminated panels after spraying with harmful chemicals. Repair required.

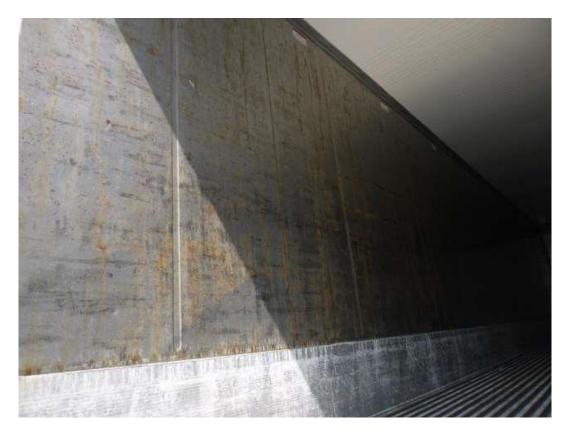
Contaminated HGSS panels showing corrosion as result of chemical spraying and scuff liner showing severe oxidation and corrosion process due to exposure to chemicals being sprayed. Repair required.

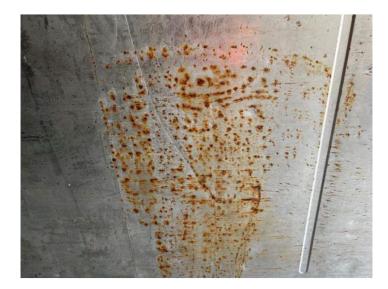
Contaminated HGSS panels showing corrosion as result of chemical spraying and scuff liner showing severe oxidation and corrosion process due to exposure to chemicals being sprayed. Repair required.

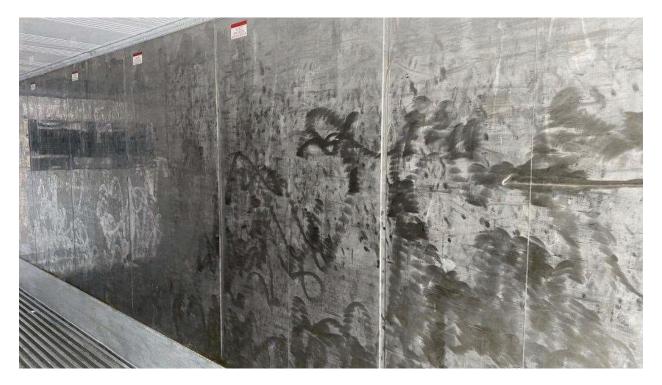
HGSS panels recently polished. Carefully look for existence of pitting, inspect machinery internal components. In the event pitting is detected, repair is required.

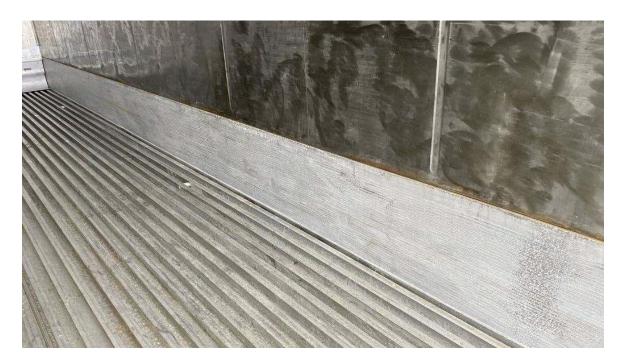
Contaminated scuff liner showing heavy oxidation and corrosion. Repair required.

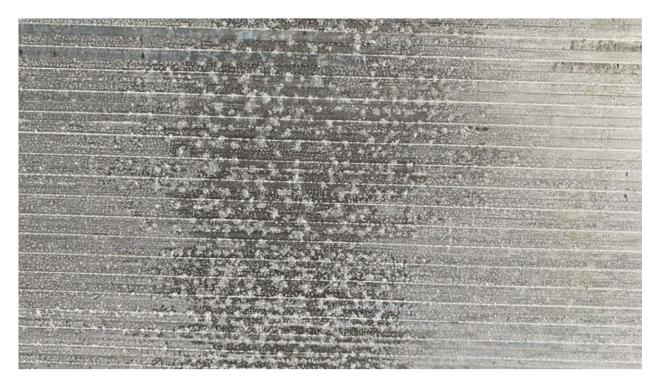
Contaminated pitting on scuff liner. Repair required.

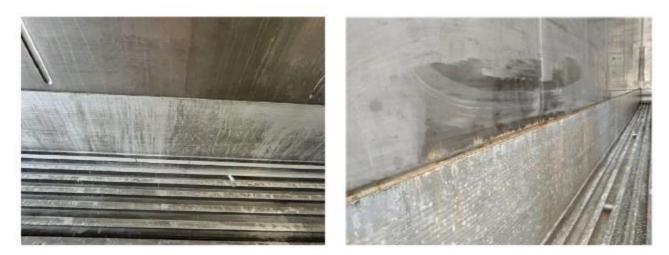
Scuff liner and aluminum T-floor showing oxidation and corrosion as result of chemicals spraying. Repair required.

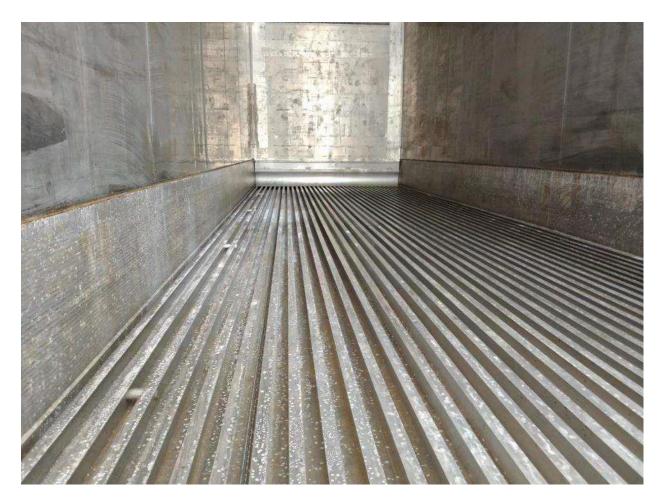
Panels, scuff liner and aluminum T-floor showing oxidation and corrosion as result of chemicals spraying. Repair required.
