28 September 2022

## IICL Technical Bulletin - RTB-009

**Purpose:** Provide inspectors with guidance on how to differentiate damage caused by contamination resulting from the spraying of chemicals in the interior of the container. Units presenting signs of contamination from chemical spraying should have the interior panels, scuff liners, floors examined, and the internal panels removed for detailed inspection of the condition of machinery components.

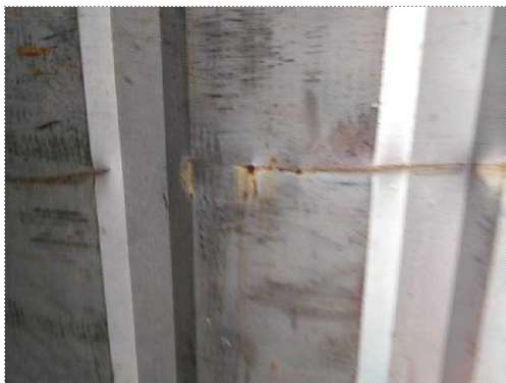
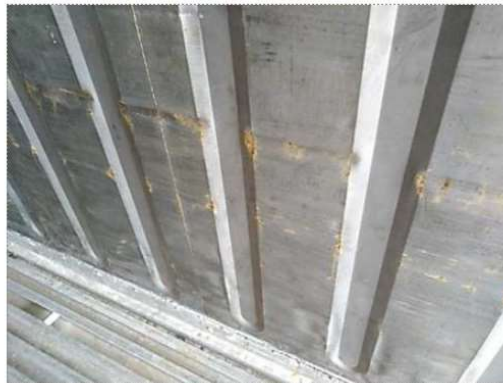
Minor rusty scratches on the HGSS panels due to loading/unloading operations, Refer to IICL General Guide for Container Cleaning, 3rd Ed.

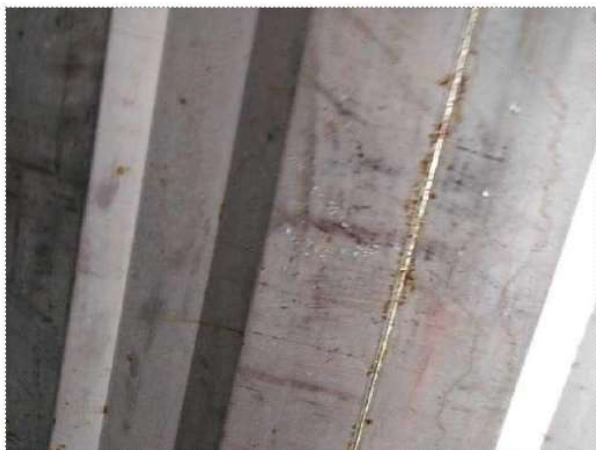
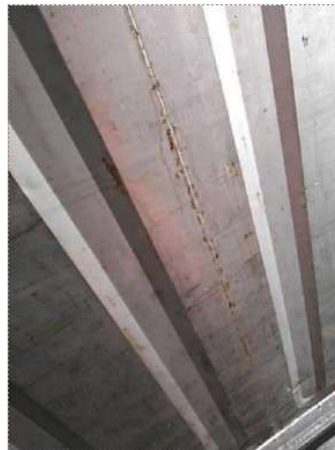
**Superficial rust near the welding seam area, Refer to IICL General Guide for Container Cleaning, 3rd Ed.**

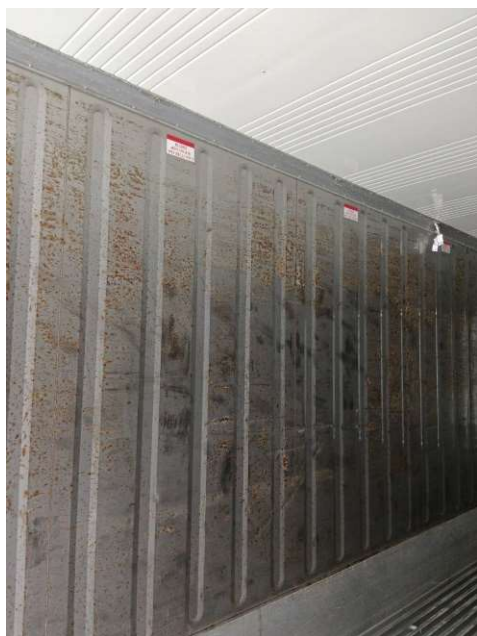
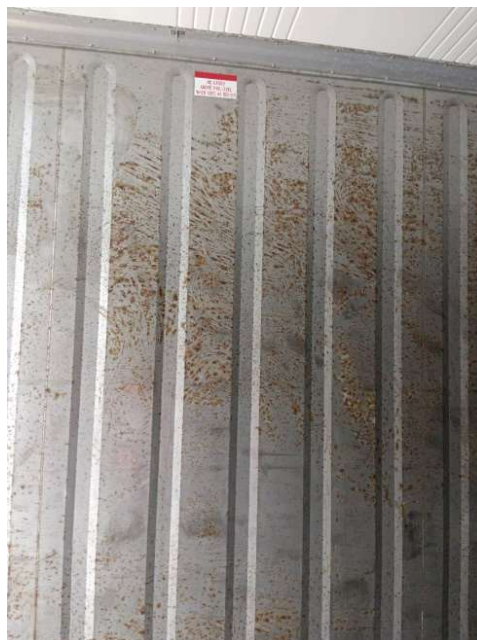
**Contaminated panels showing rust/corrosion marks spread over large areas including weld seams, corrugated and flat surfaces. Above photos depict typical damage caused by contamination as result of chemical spraying. Repair required.**

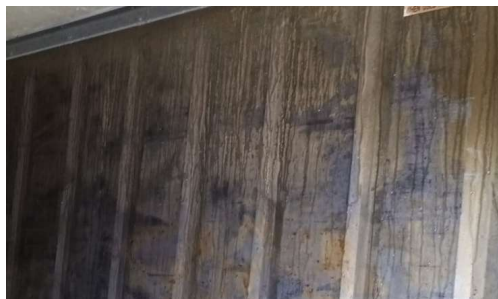
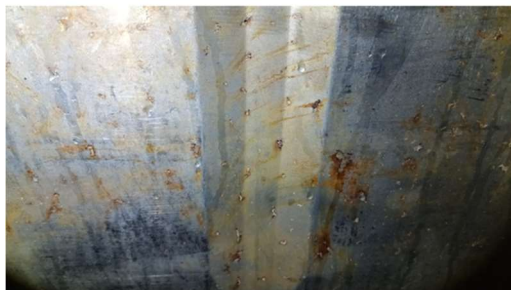
**Contaminated panels showing rust/corrosion marks spread over large areas including weld seams, corrugated and flat surfaces. Above photos depict typical damage caused by contamination as result of chemical spraying. Repair required.**

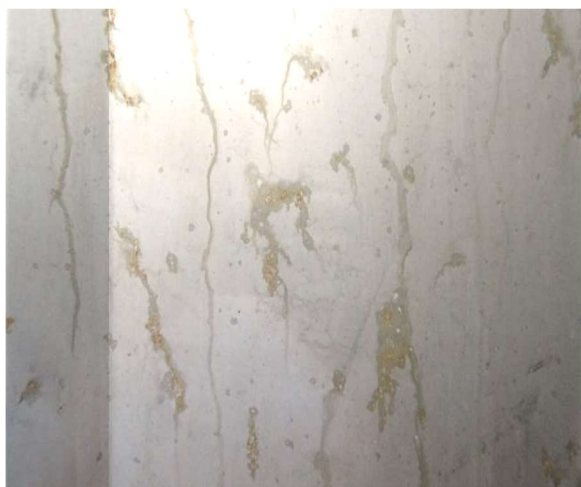
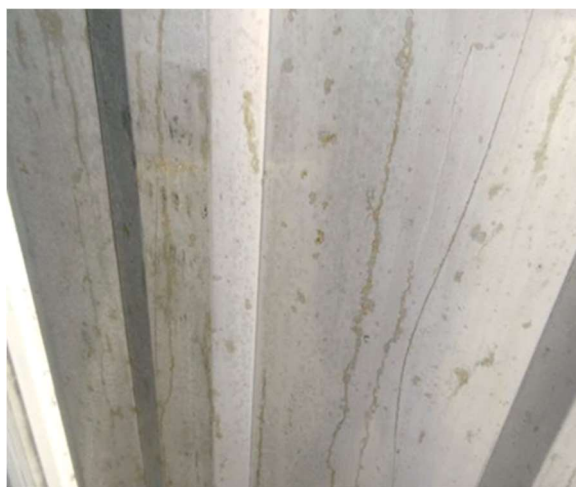
**Rust/corrosion stains. Above photos depict typical damage resulting from contaminated panels after spraying with harmful chemicals. Repair required.**

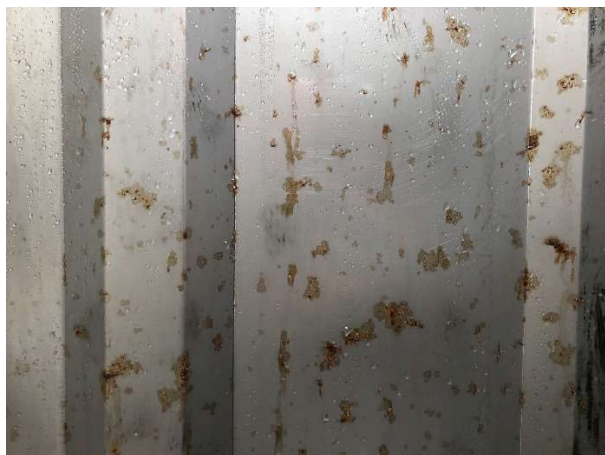
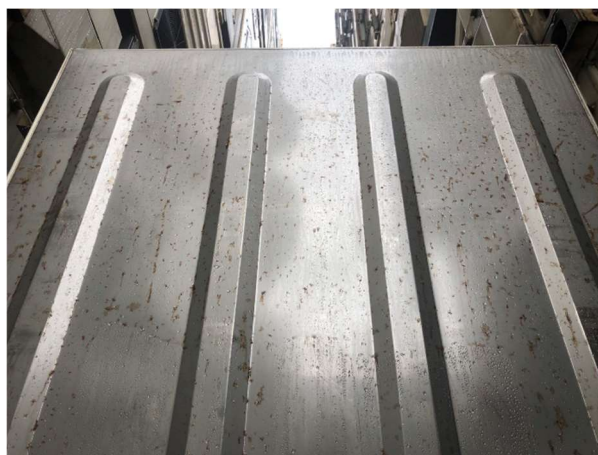
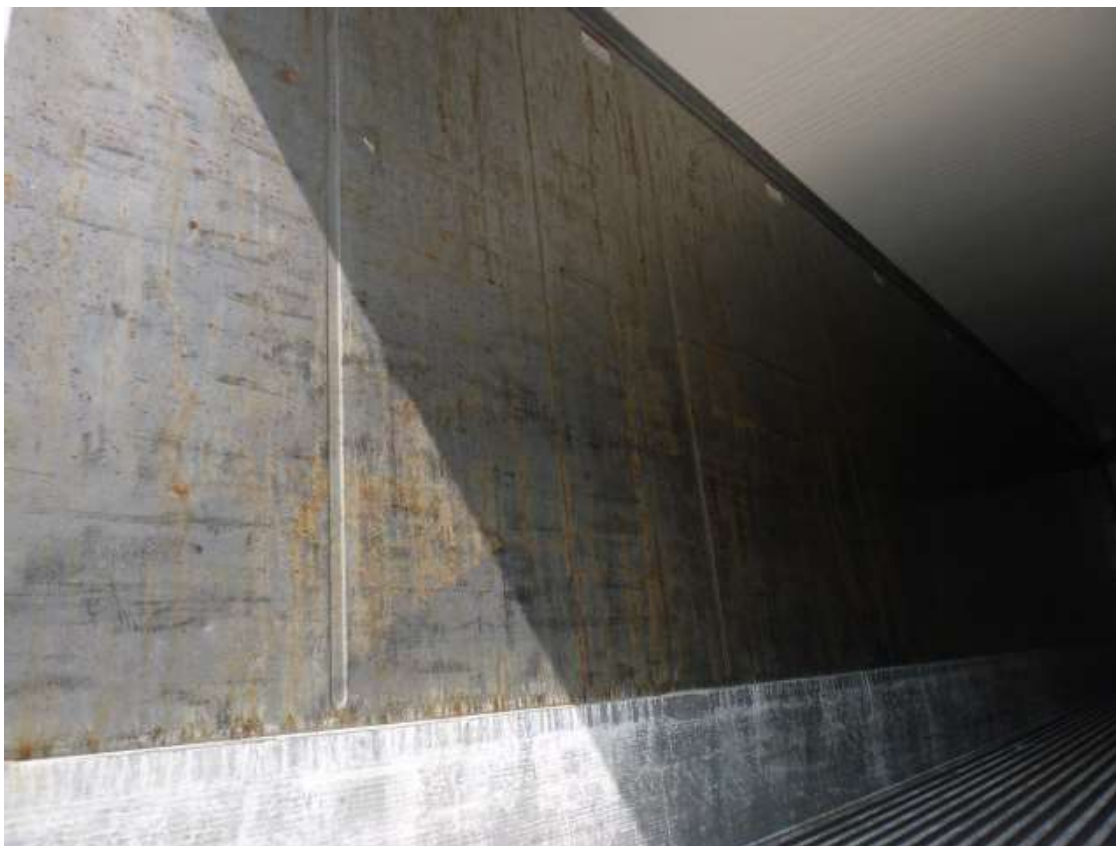
**Contaminated HGSS panels showing corrosion as result of chemical spraying and scuff liner showing severe oxidation and corrosion process due to exposure to chemicals being sprayed. Repair required.**

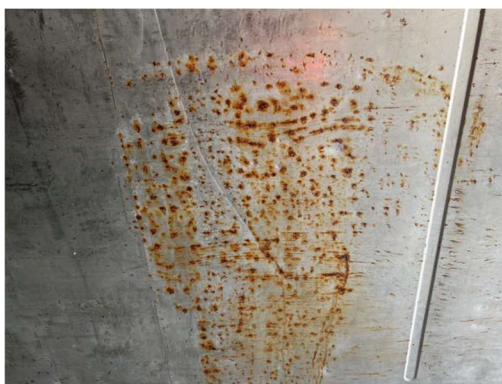
**Contaminated HGSS panels showing corrosion as result of chemical spraying and scuff liner showing severe oxidation and corrosion process due to exposure to chemicals being sprayed. Repair required.**

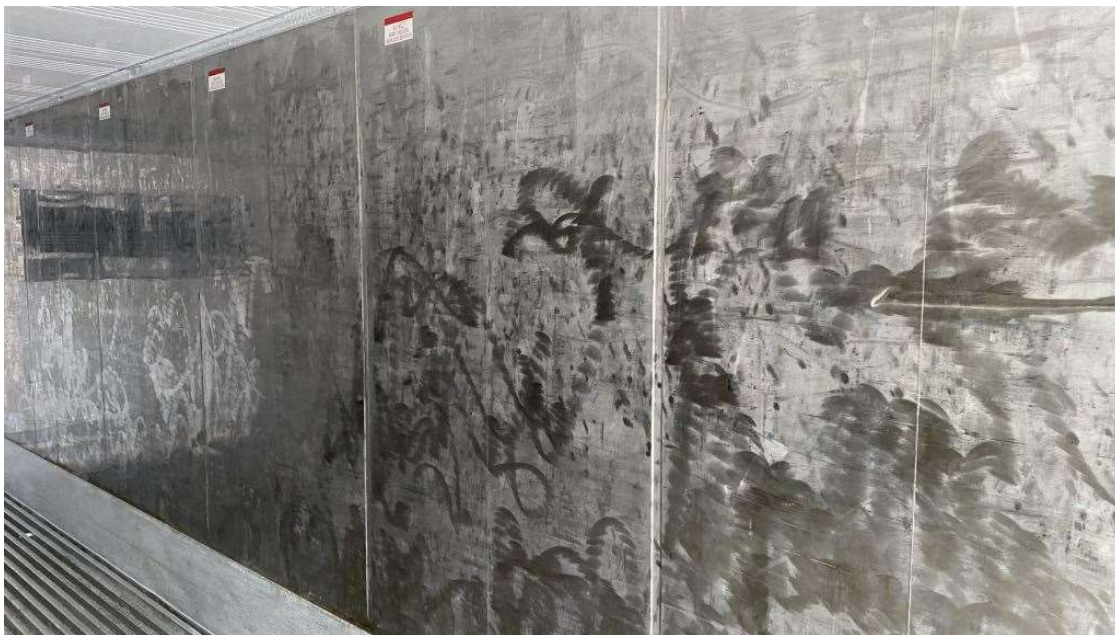
**HGSS panels recently polished. Carefully look for existence of pitting, inspect machinery internal components.**

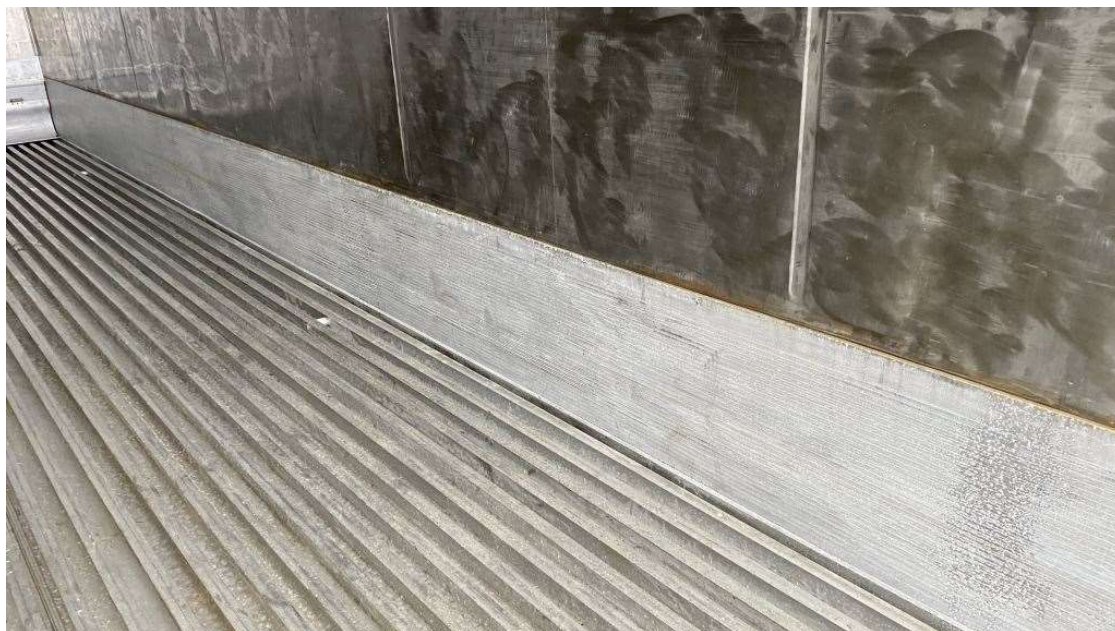
**Contaminated scuff liner showing heavy oxidation and corrosion. Repair required.**

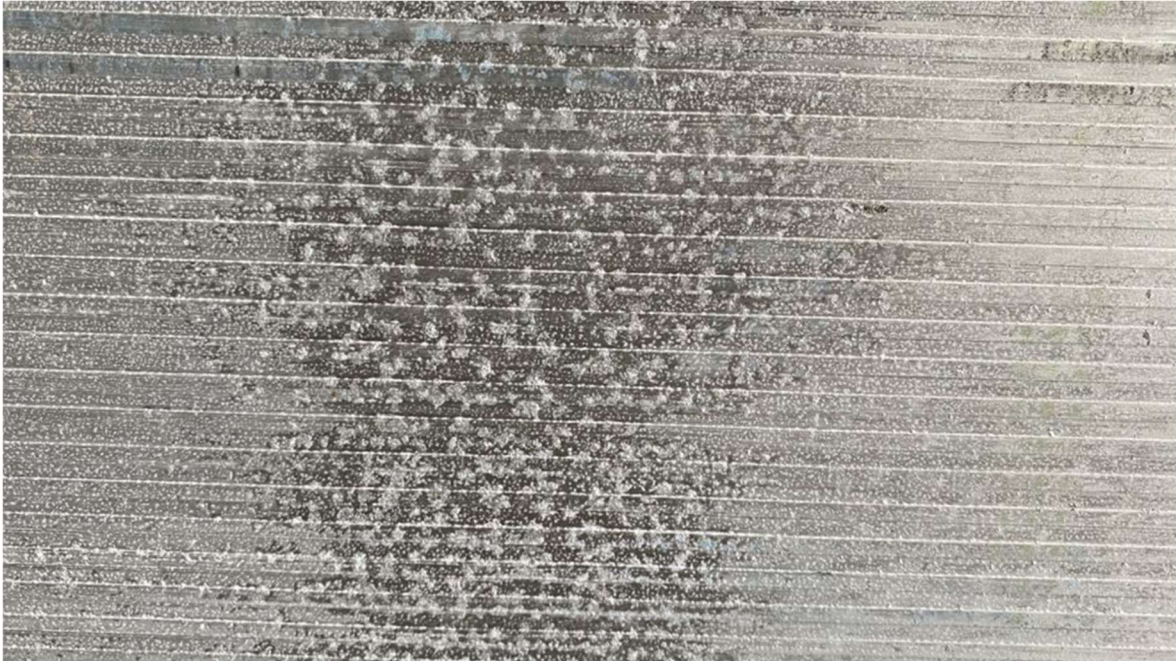
**Contaminated pitting on scuff liner. Repair required.**

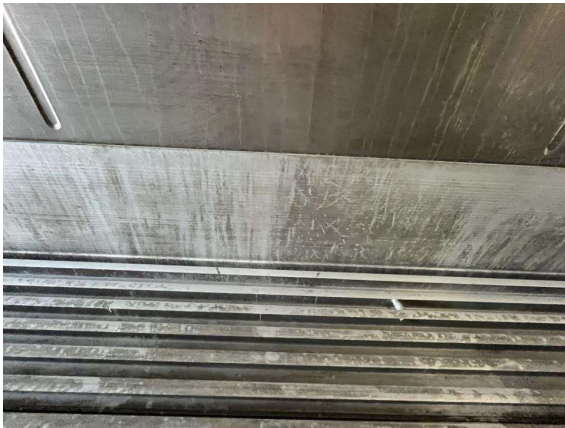
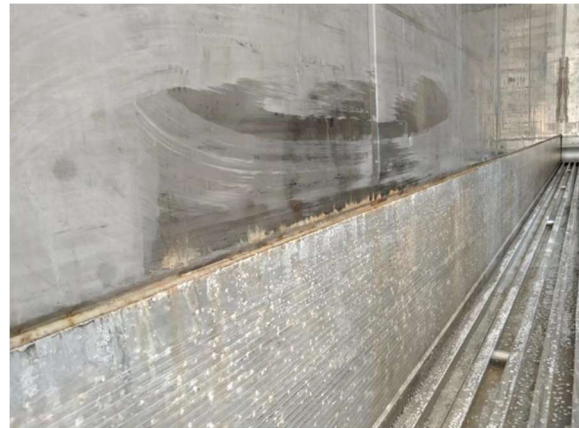
**Scuff liner and aluminium T-floor showing oxidation and corrosion as result of chemicals spraying.  
Repair required.**

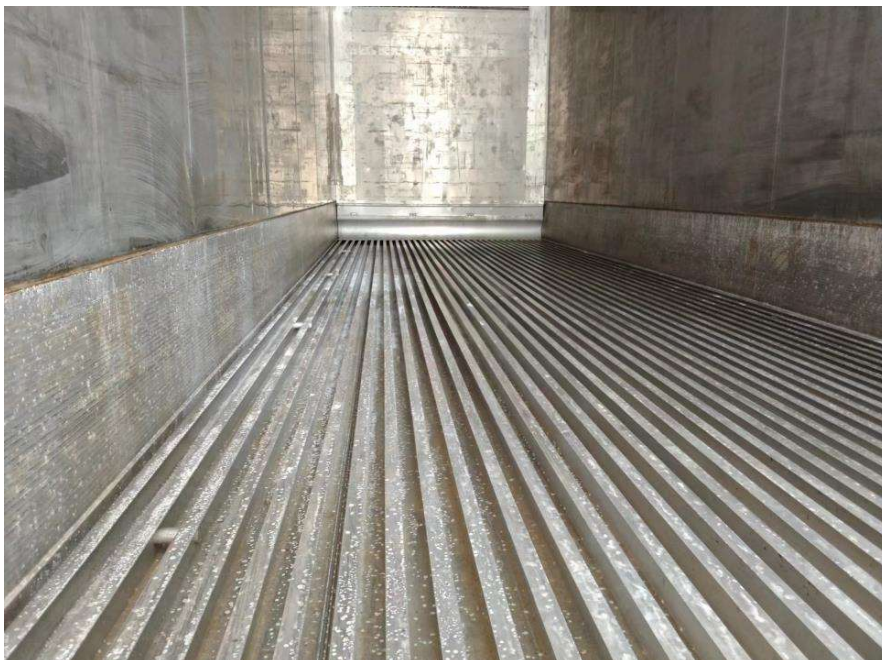
**Panels, scuff liner and aluminium T-floor showing oxidation and corrosion as result of chemicals spraying. Repair required.**

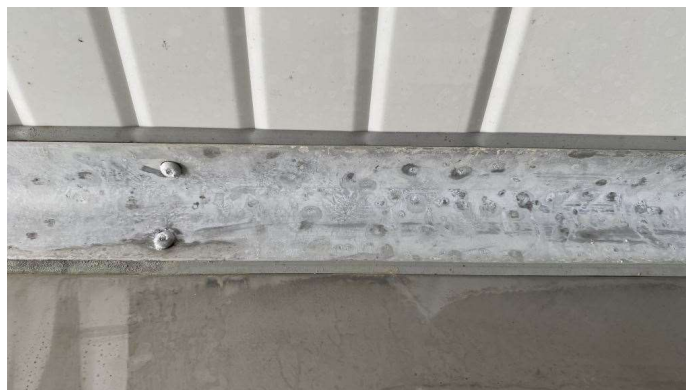
**Contaminated interior aluminium coving showing oxidation and corrosion due to chemical spraying. Repair required.**
