## **IICL TB 003**, 1 May 2005

## Title: "Finger Cracking in Plywood Floor Boards".

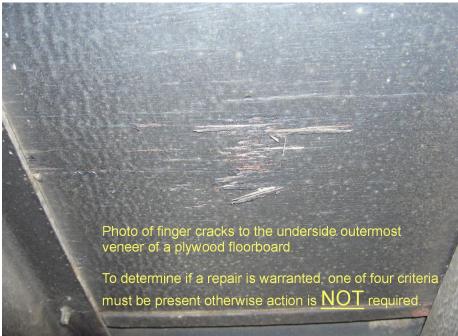
A "<u>finger crack</u>" is a separation in a surface veneer running transverse combined with separations running longitudinal at both ends of the transverse separation.

Not all cases of finger cracking will be repair worthy. Finger cracking will be repair worthy only **when** accompanied by one or more of the following conditions:

- Visible sign of impact on the opposite side
- Damage to adjacent components, i.e., crossmembers, sills, floor rails, hat sections
- Visible bowing of the opposite side of the floor
- Hollow sound when hammer tested
