IICL Technical Bulletin - TB-021 (Revised March 2022)

Title: Repair limitations on understructure components

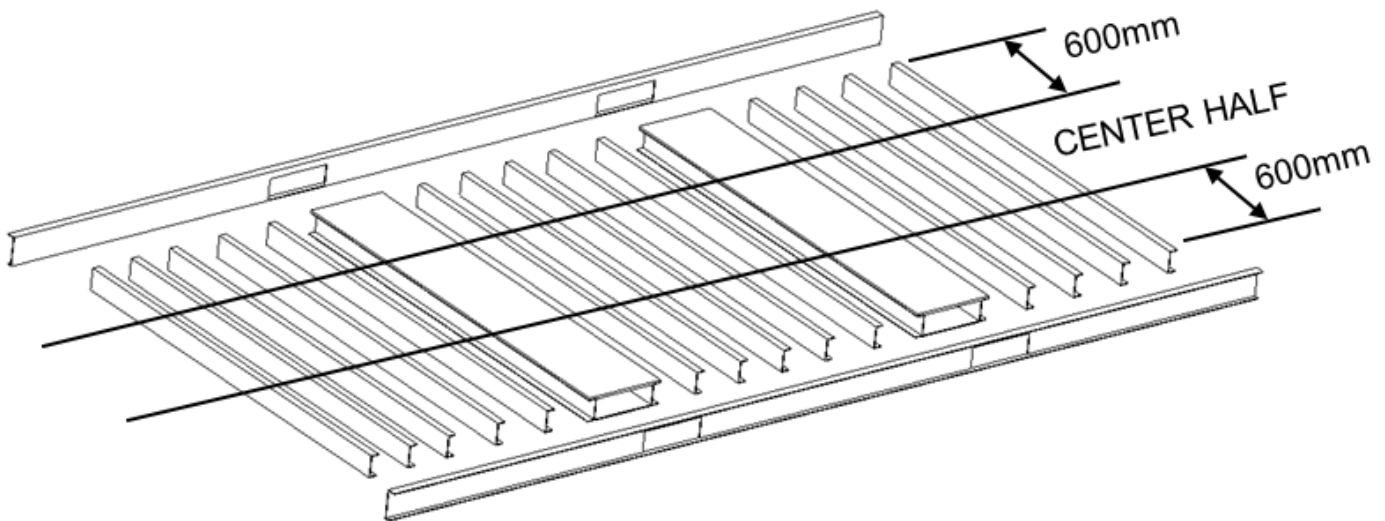
Weld repairs to members (crossmember / forklift pocket side wall) are not allowed within the center one half of two adjacent members. The center one half of a member is defined as that part of the member that is greater than 600mm from the nearest bottom side rail. If two adjacent members have weld repairs within the center halves, either one of the members must either be replaced or the inserts must be lengthened such that they do not terminate within the center half of the member.

NOT ACCEPTABLE

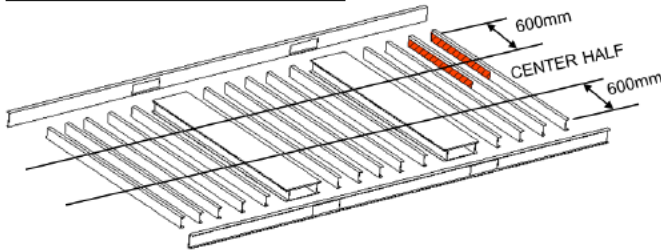
NOT ACCEPTABLE

The insert on the right side is acceptable because it is the 1st crossmember with an insert. But the 2nd insert on the left is not acceptable because the weld seam terminates in the center half of the container.

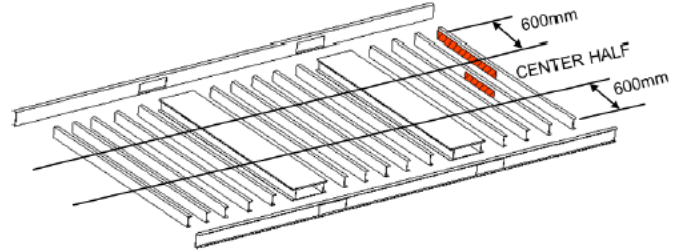
NOT ACCEPTABLE

The insert on the right side is acceptable because it is the 1st crossmember with an insert. The 2nd insert on the left is not acceptable because the weld seams terminate in the center half of the container.

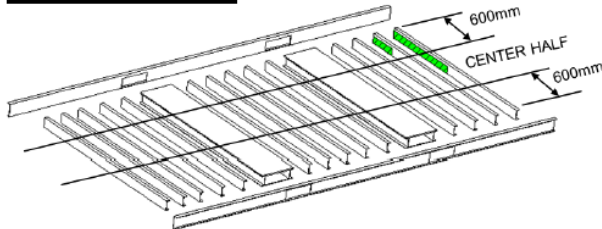
ACCEPTABLE

The insert on the right side is acceptable because it is the 1st crossmember with an insert. The 2nd insert on the left is also acceptable because the weld seams terminate within 600mm from the bottom side rail.

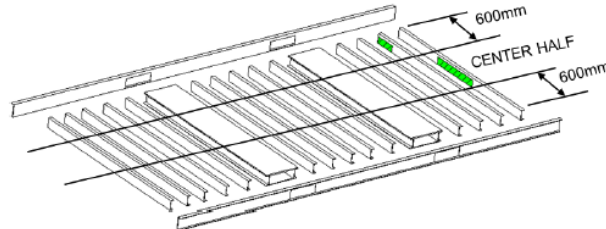
ACCEPTABLE

The insert on the right side is acceptable because it is the 1st crossmember with an insert. The 2nd insert on the left is also acceptable because the weld seams terminate within 600mm from the bottom side rail.

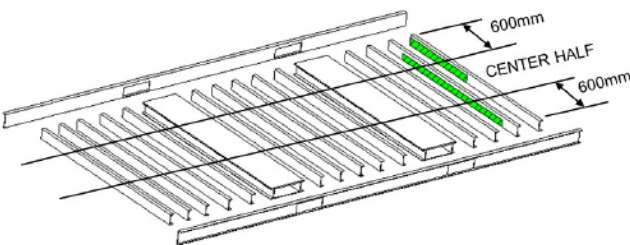
ACCEPTABLE

The insert on the right side is acceptable because it is the 1st crossmember with an insert. The 2nd insert on the left is also acceptable because the weld seams terminate within 600mm from the bottom side rails.

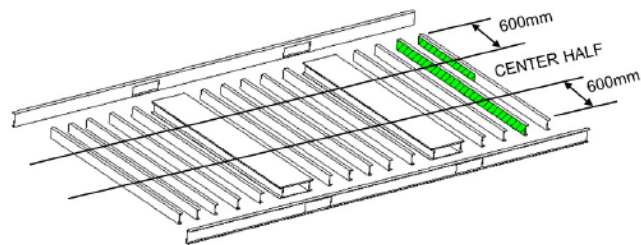
ACCEPTABLE

The insert on the right side is acceptable because it is the 1st crossmember with an insert. The 2nd cross member is also acceptable because it is actually a full replacement.

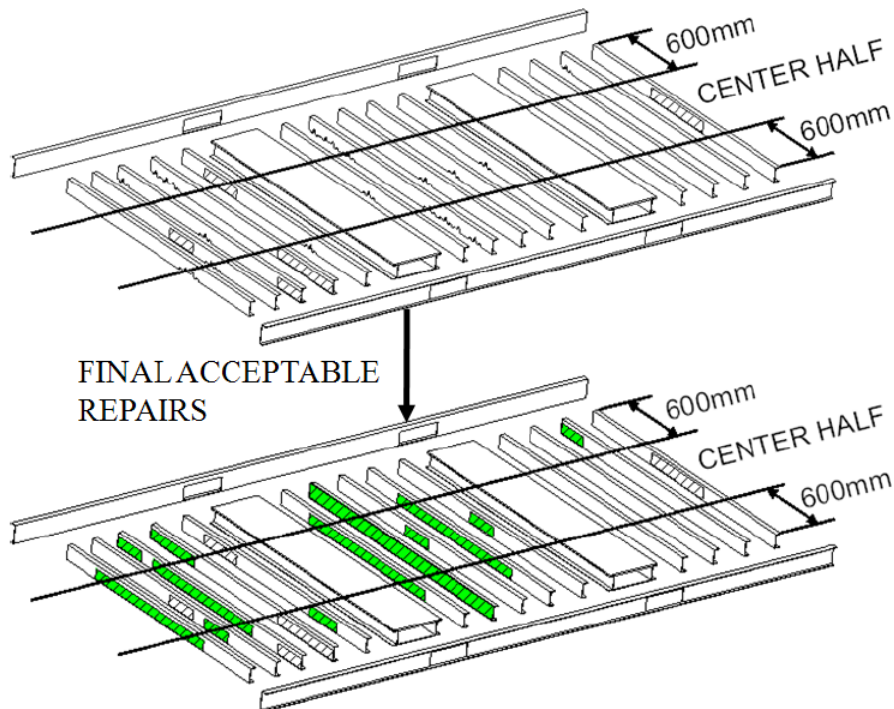
FULL CONTAINER EXAMPLE

AN EXAMPLE of new damage locations and pre-existing inserts.

Acceptable inserts based on new damage locations and pre-existing inserts, as shown above. It is important to note that this is one EXAMPLE of a possible combination of damage and acceptable repair inserts. There may be many different possibilities. This drawing should only be used as a guide to determine the safest and most economical type of repair on a case-by-case basis.

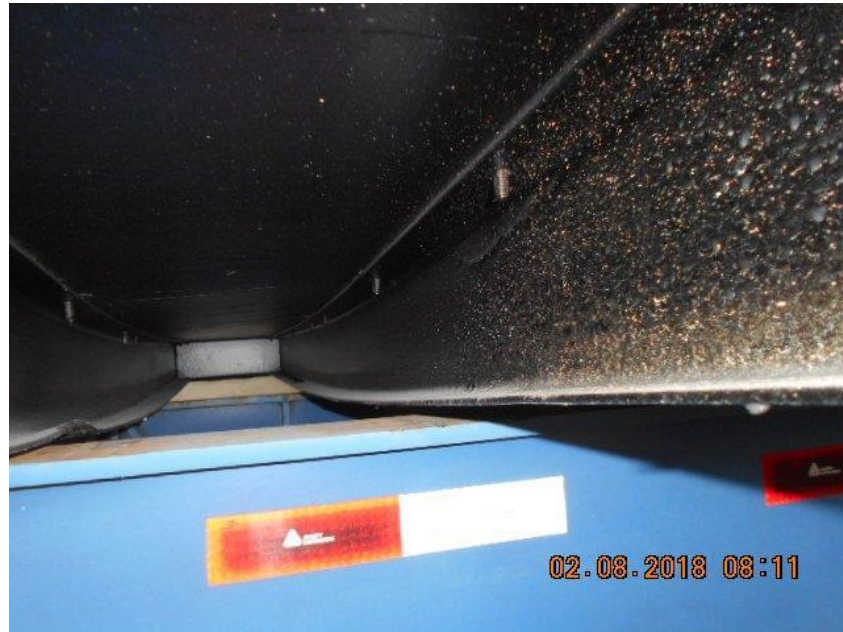
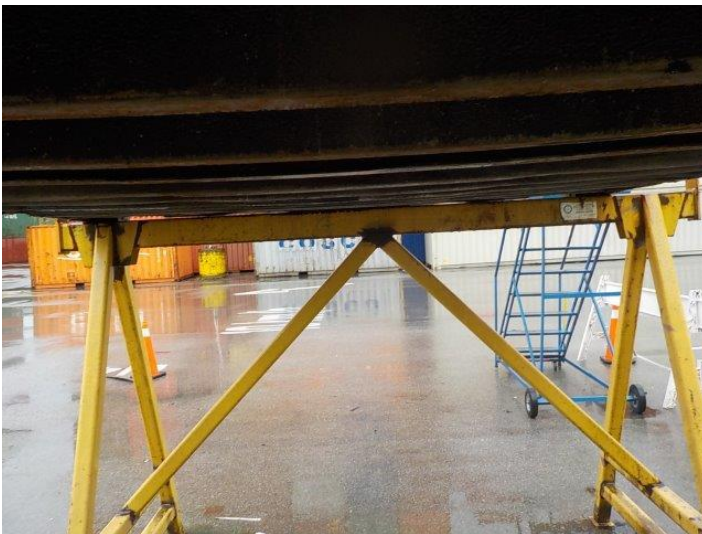
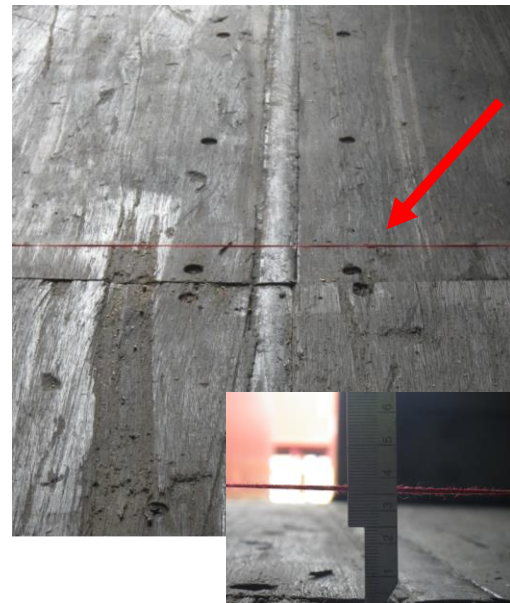
The following photos depict some examples of bowed down understructure components.

The IICL repair recommendation is that bowed down understructure components, in excess of IICL tolerances, should be repaired through:

1. Full Replacement
2. Insert within the limitations specified on page 2.
