Open Top Technical Bulletin OT TB 001, December 2013

Title: Open Top Container Roof Bows – Updated Criteria

Component: Roof Bows

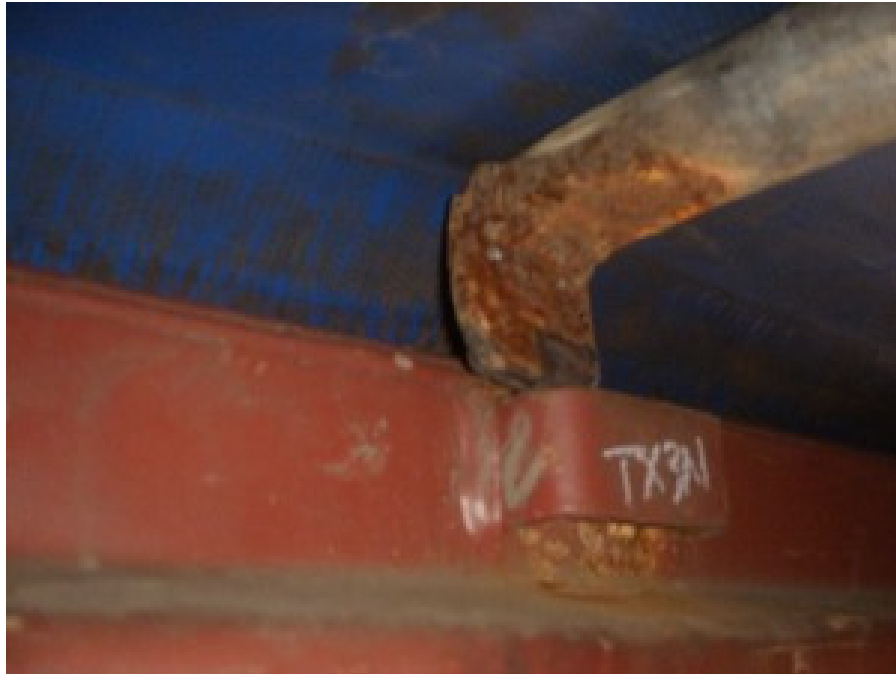
Improperly fitted roof bow end

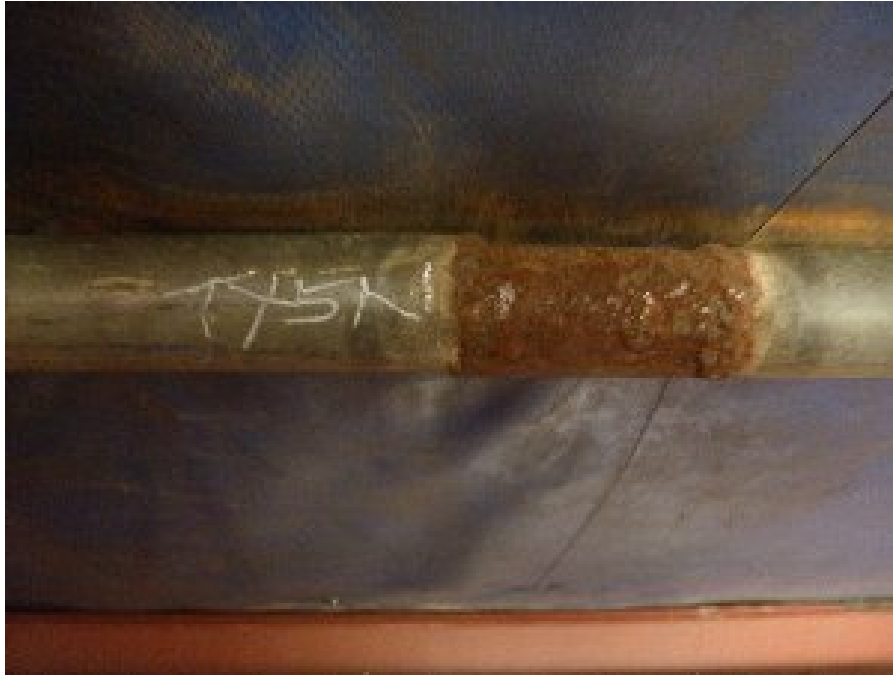
Improper Section
Will cause tarp damage

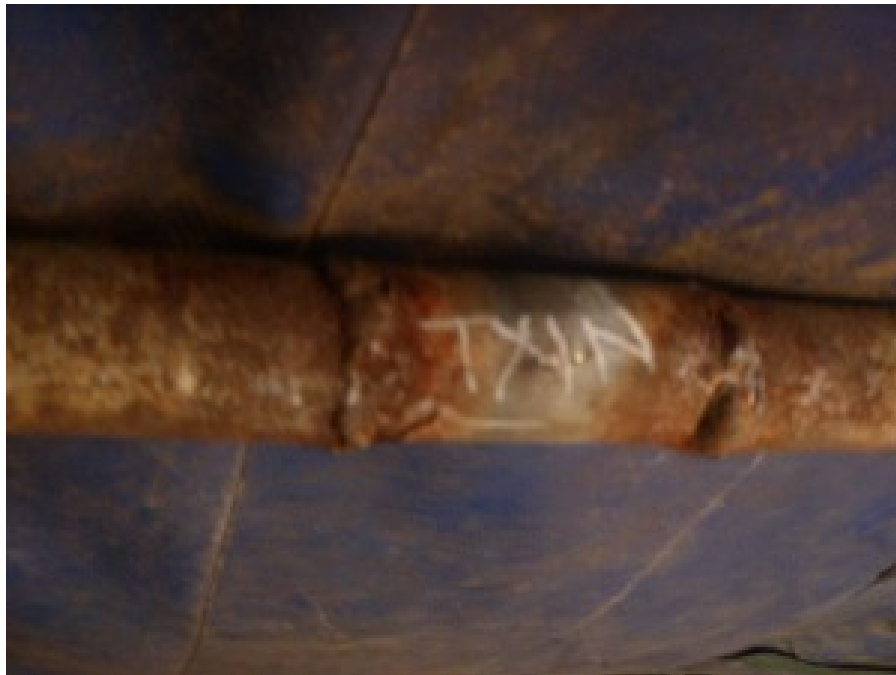
Improper section

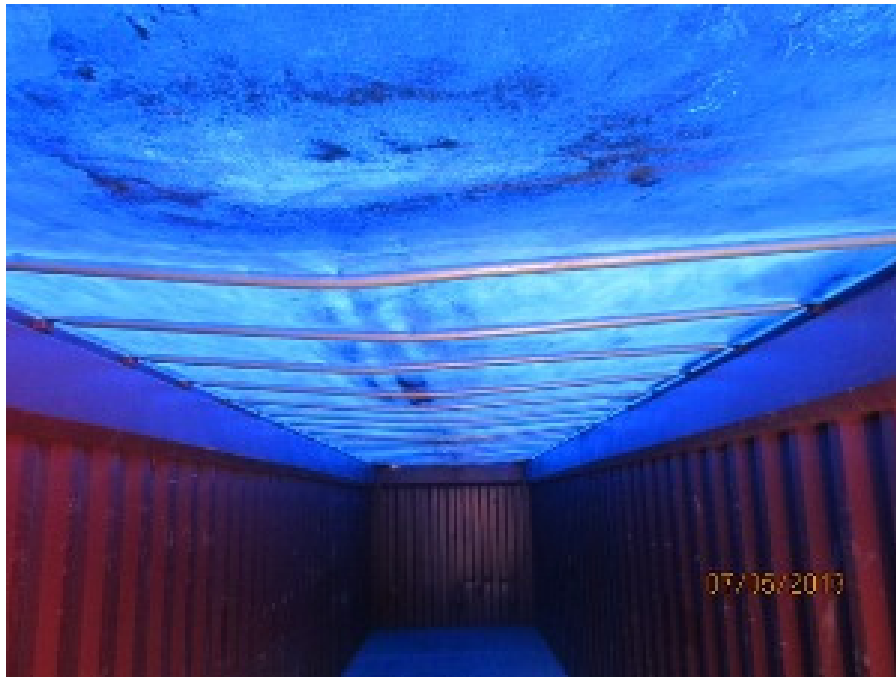
Roof bows to thin
No camber

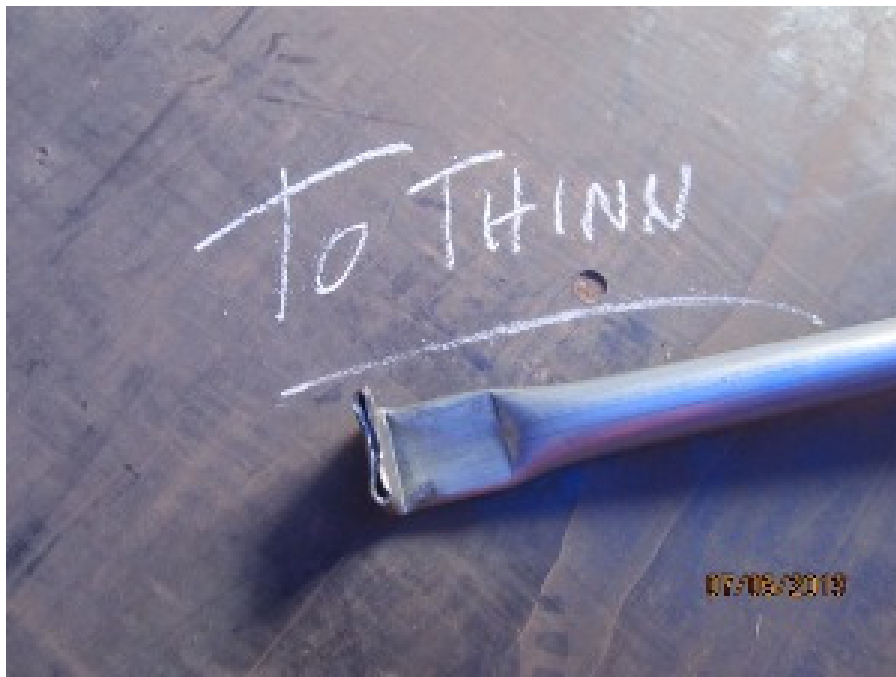
Improperly fitted roof bo end

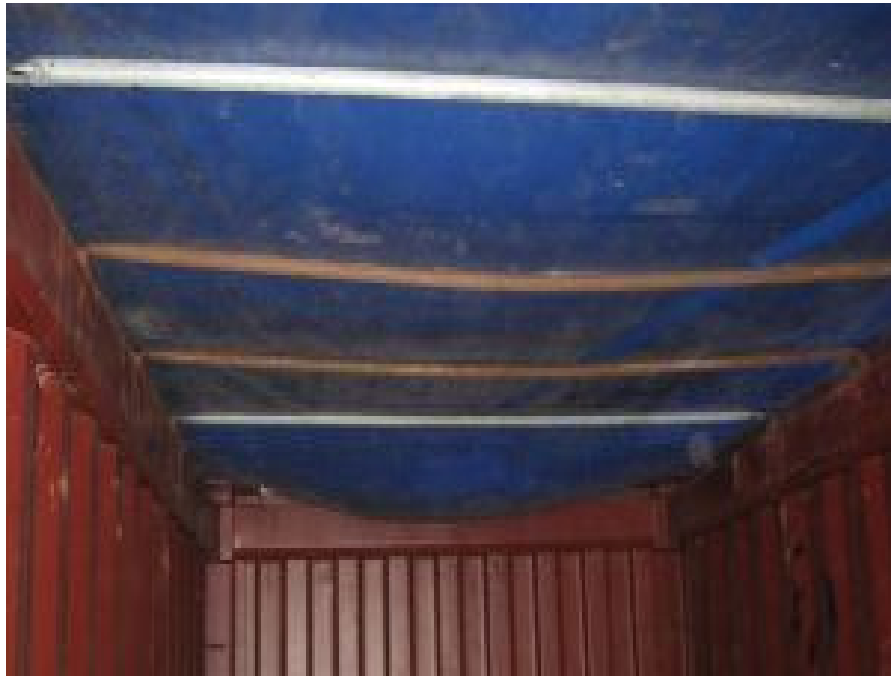
Improper bows
Wrong material (not galvanized)
No cammber
