IICL Technical Bulletin - RTB-009 – addendum II.

Minor rusty scratches on the HGSS panels due to loading/unloading operations, Refer to IICL General Guide for Container Cleaning, 3rd Ed.

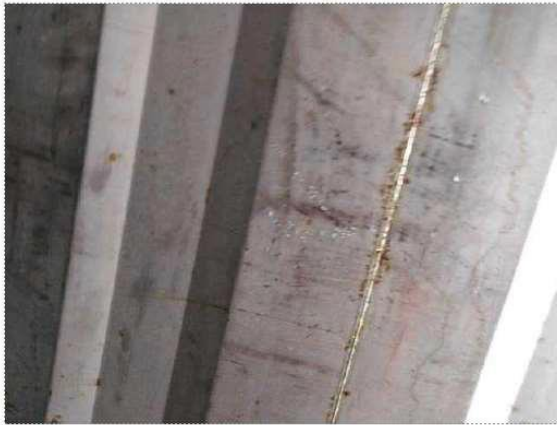
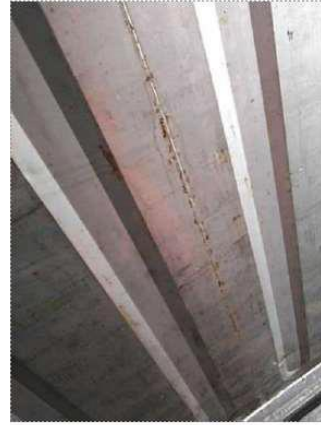
Superficial rust near the welding seam area, Refer to IICL General Guide for Container Cleaning, 3rd Ed.

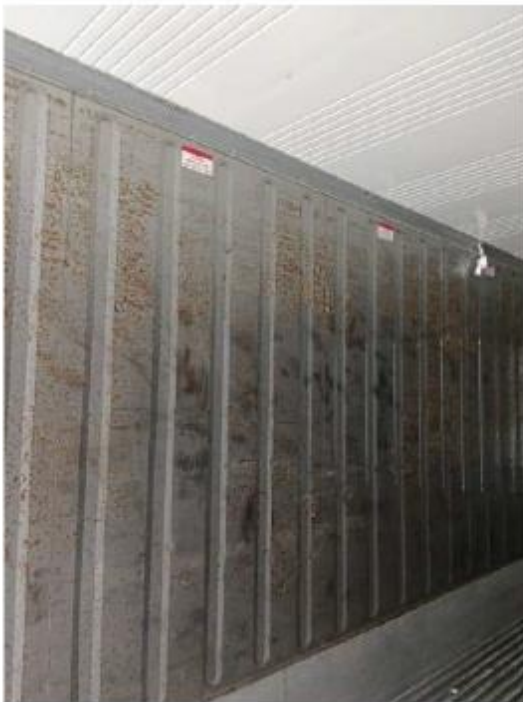
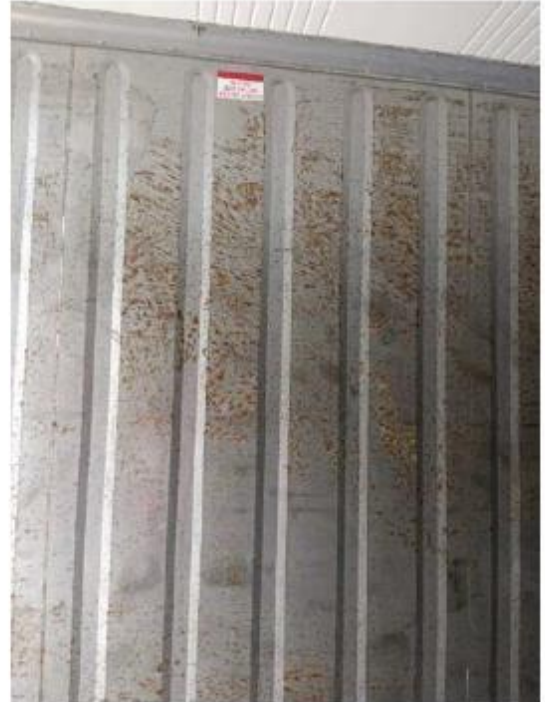
Contaminated panels showing rust/corrosion marks spread over large areas including weld seams, corrugated and flat surfaces. Above photos depict typical damage caused by contamination as result of chemical spraying. Repair required.

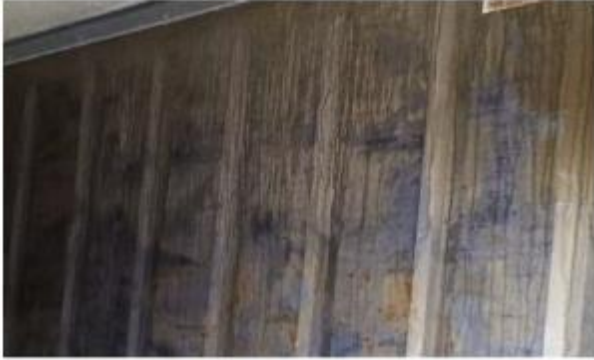
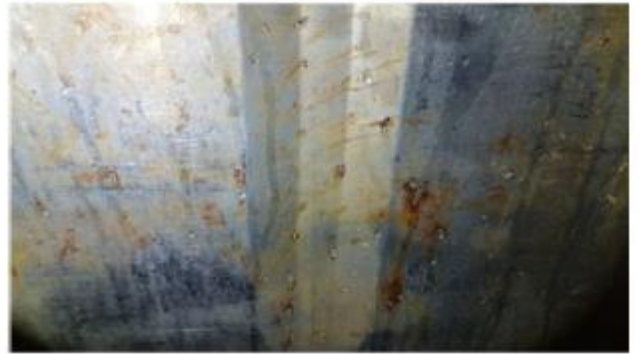
Contaminated panels showing rust/corrosion marks spread over large areas including weld seams, corrugated and flat surfaces. Above photos depict typical damage caused by contamination as result of chemical spraying. Repair required.

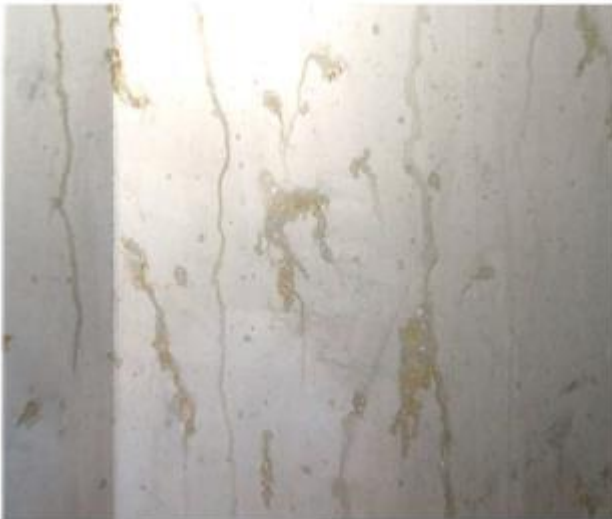
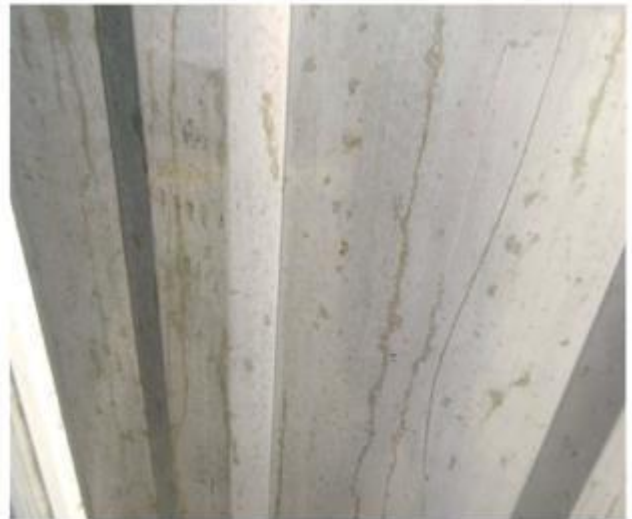
Rust/corrosion stains. Above photos depict typical damage resulting from contaminated panels after spraying with harmful chemicals. Repair required.

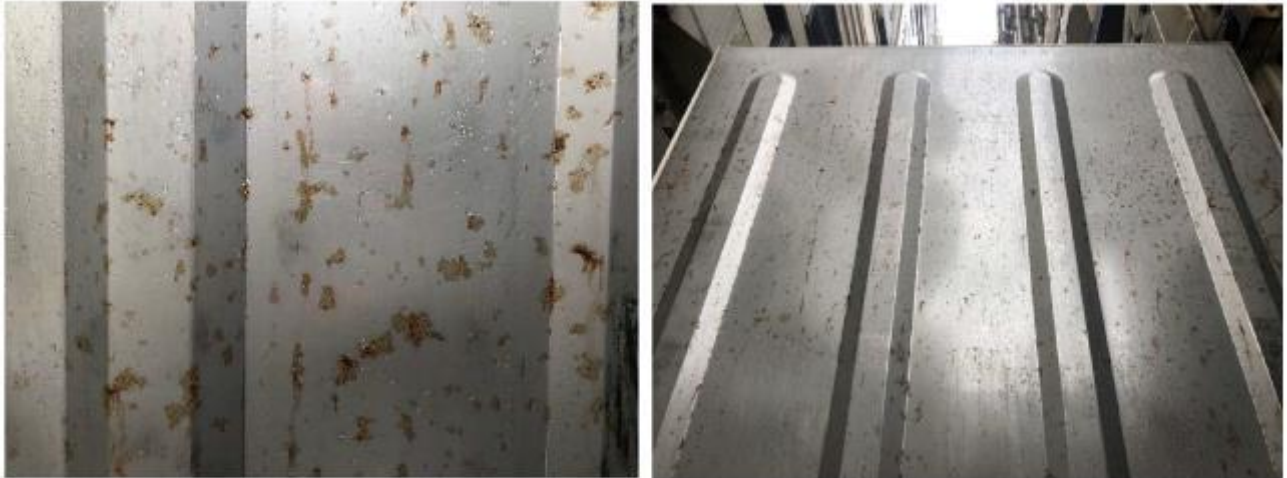
Rust/corrosion stains and pitting. Above photos depict typical damage resulting from contaminated panels after spraying with harmful chemicals. Repair required.

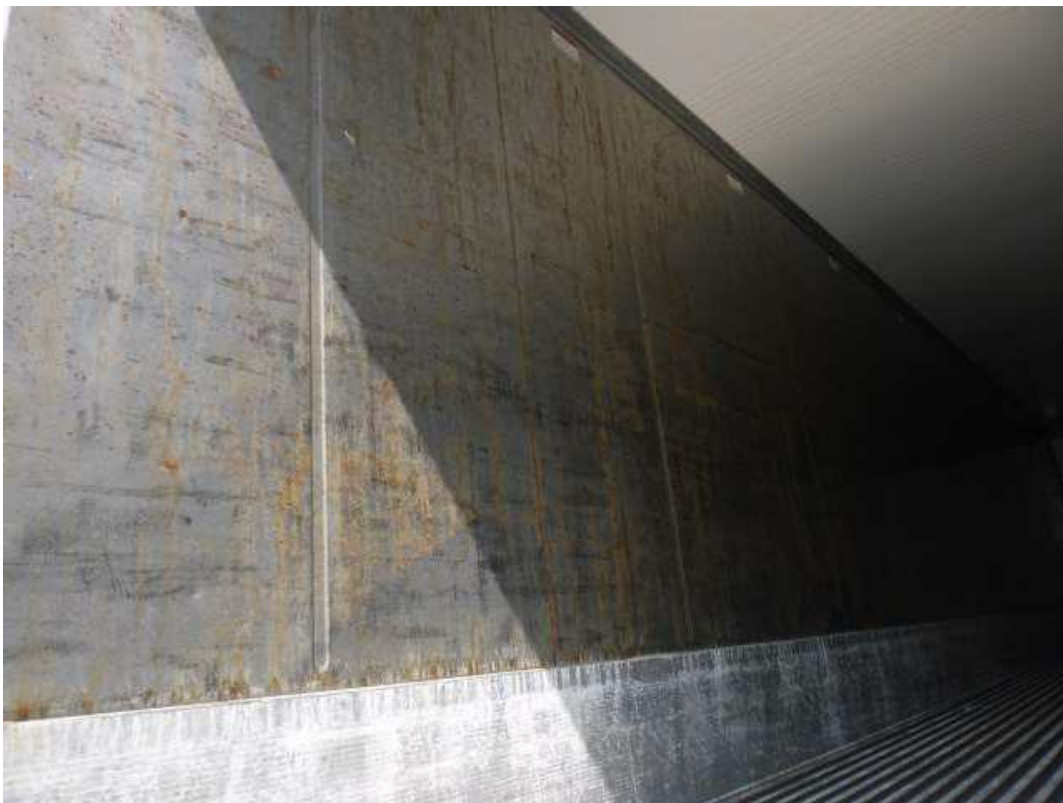
Contaminated HGSS panels showing corrosion as result of chemical spraying and scuff liner showing severe oxidation and corrosion process due to exposure to chemicals being sprayed. Repair required.

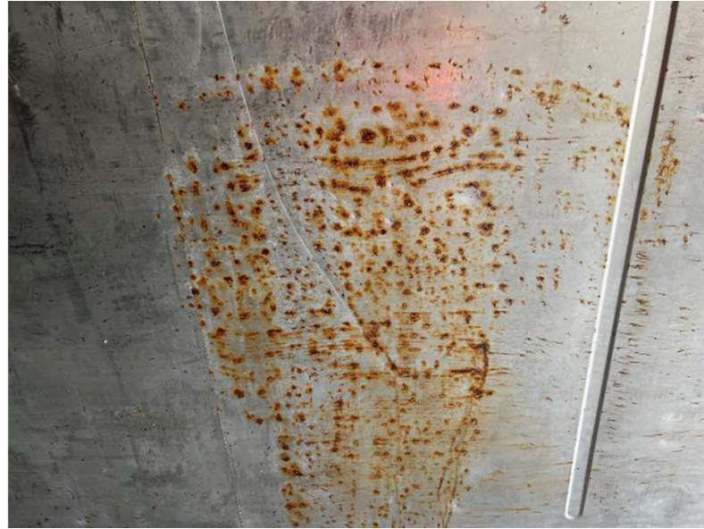
Contaminated HGSS panels showing corrosion as result of chemical spraying and scuff liner showing severe oxidation and corrosion process due to exposure to chemicals being sprayed. Repair required.

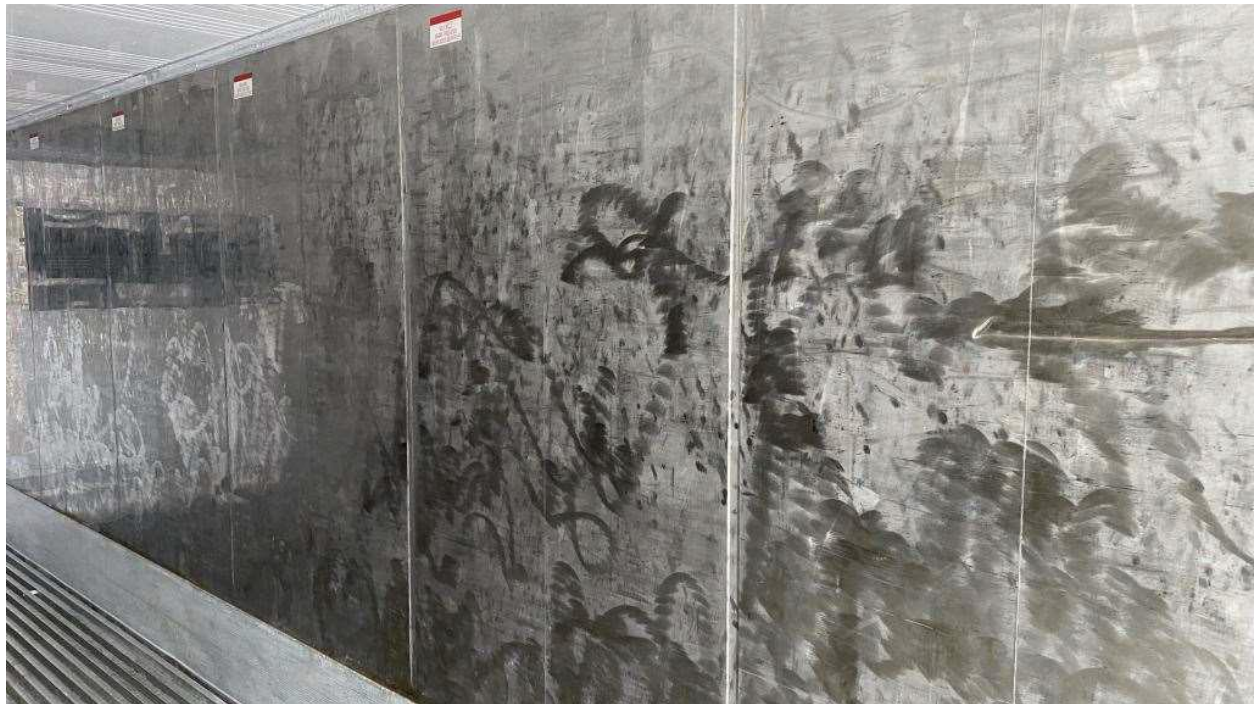
HGSS panels recently polished. Carefully look for existence of pitting, inspect machinery internal components. In the event pitting is detected, repair is required.

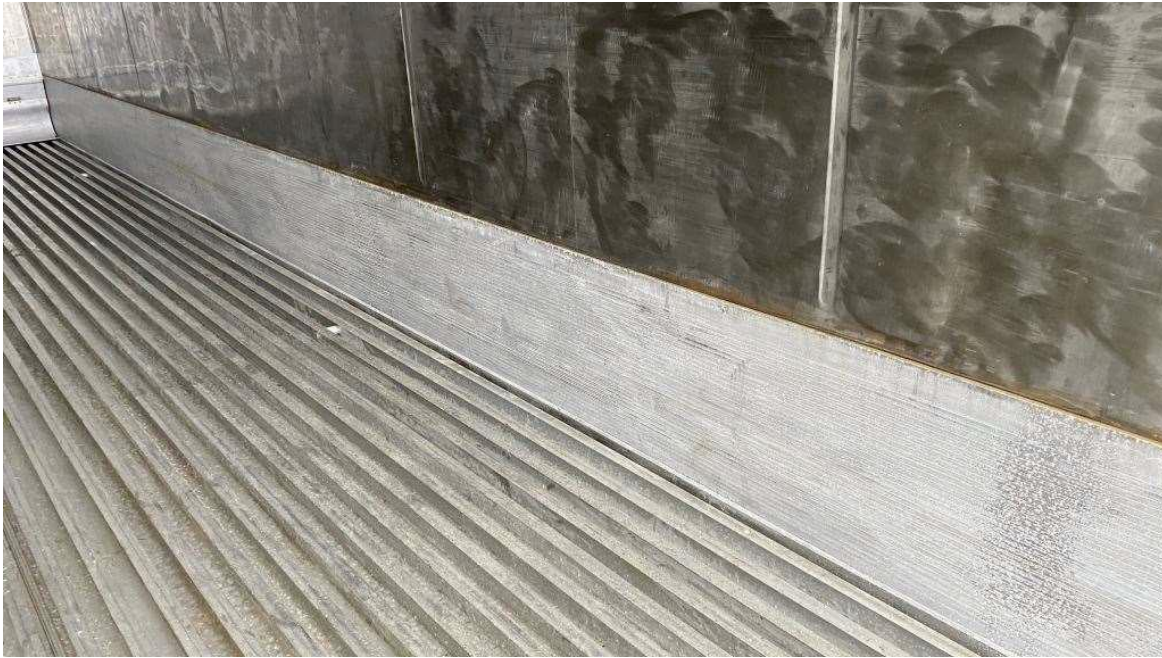
Contaminated scuff liner showing heavy oxidation and corrosion. Repair required.

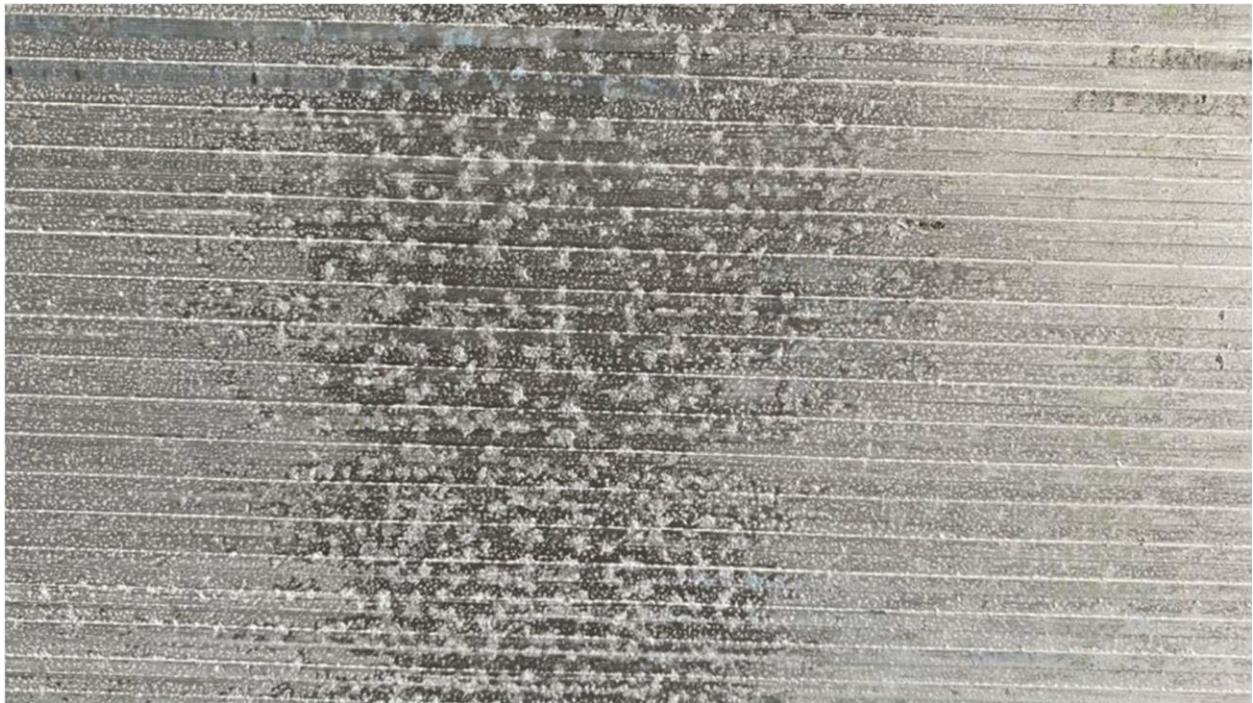
Contaminated pitting on scuff liner. Repair required.

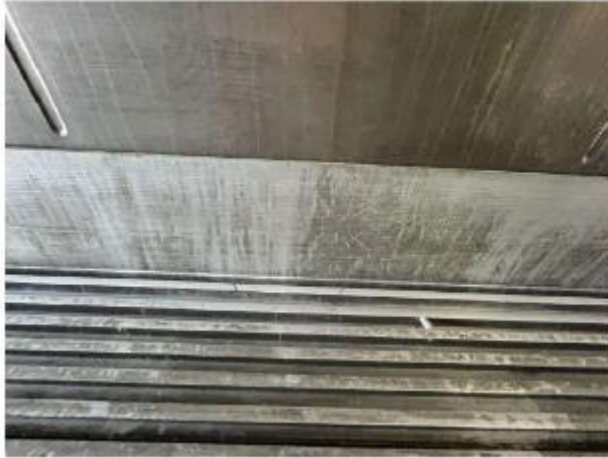
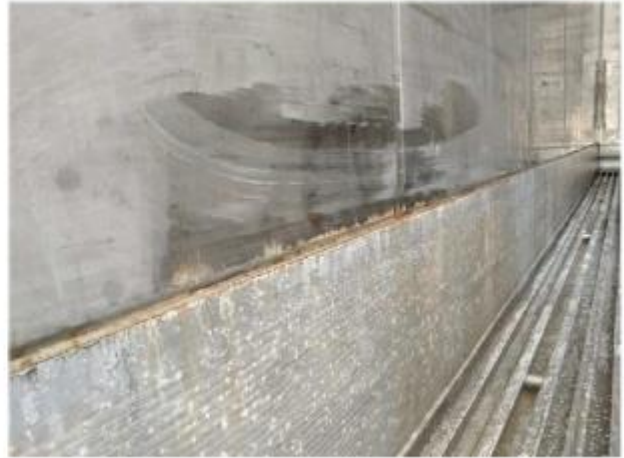
Scuff liner and aluminum T-floor showing oxidation and corrosion as result of chemicals spraying. Repair required.

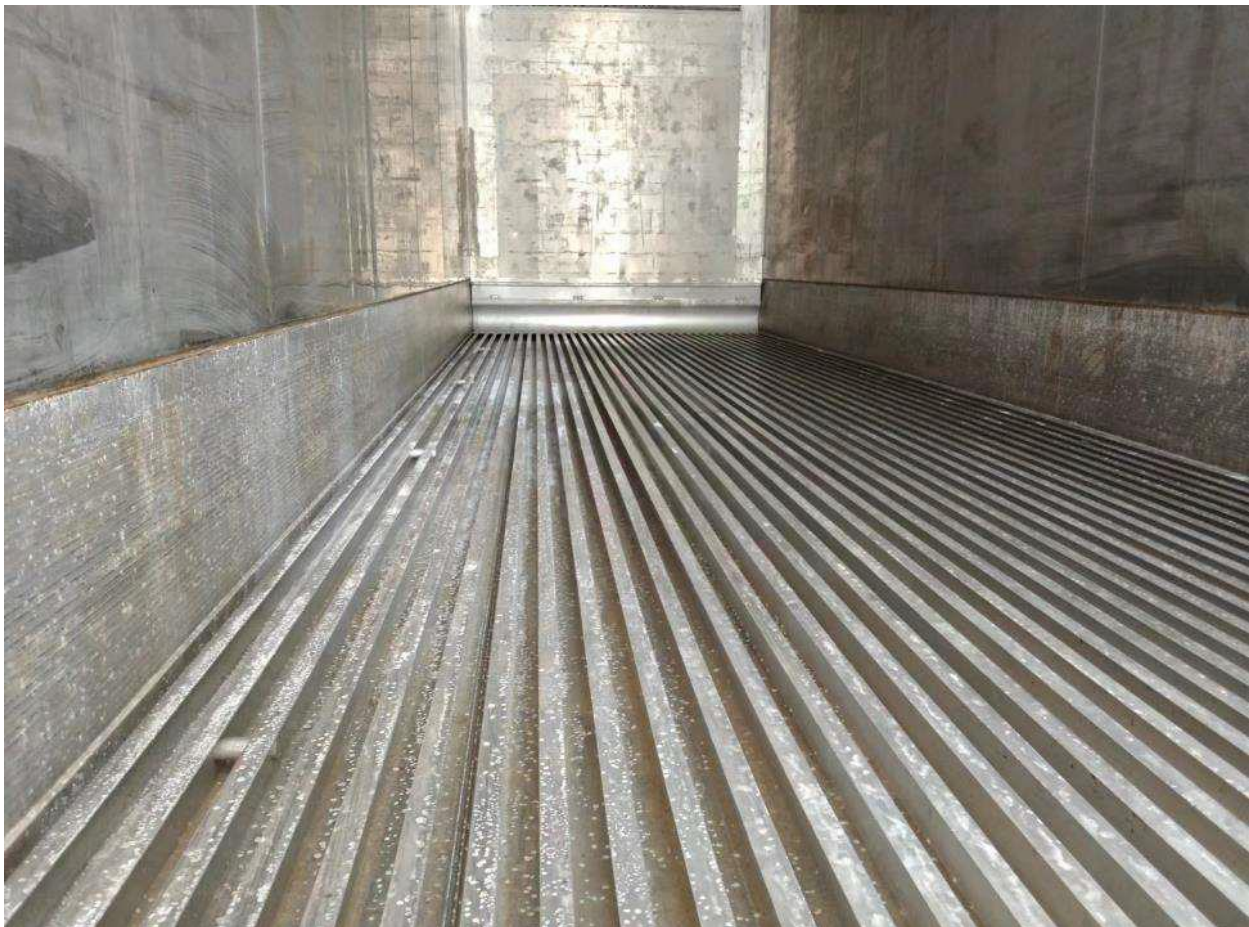
Panels, scuff liner and aluminum T-floor showing oxidation and corrosion as result of chemicals spraying. Repair required.

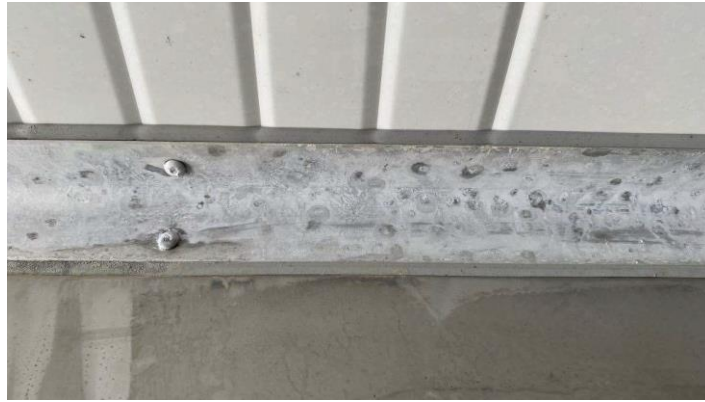
Contaminated interior aluminum coving showing oxidation and corrosion due to chemical spraying. Repair required.
