January 27, 2021

## IICL Refrigerated Container Technical Bulletin – RTB 007 rev1.

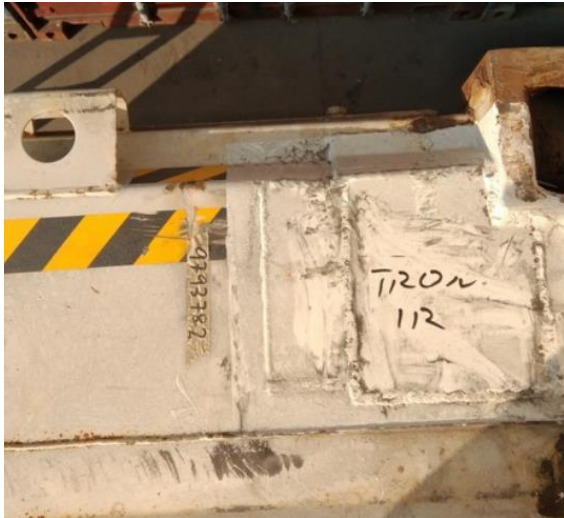
Non-conforming patch exceeds the original size of the Corner Protection Plate.

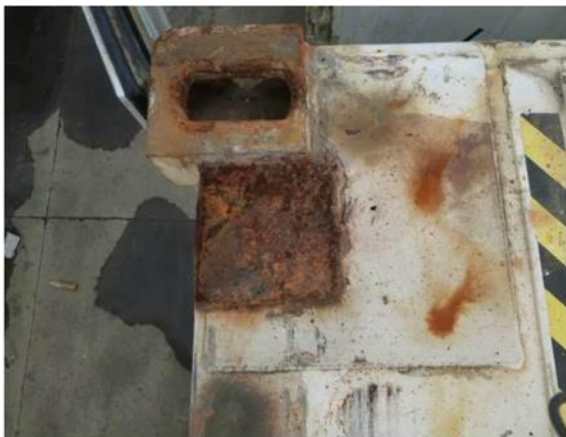
Non-conforming repair on Corner Protection Plate. Patch exceeds original size of Corner Protection Plate. Excessive corrosion likely due to poor coating applied.

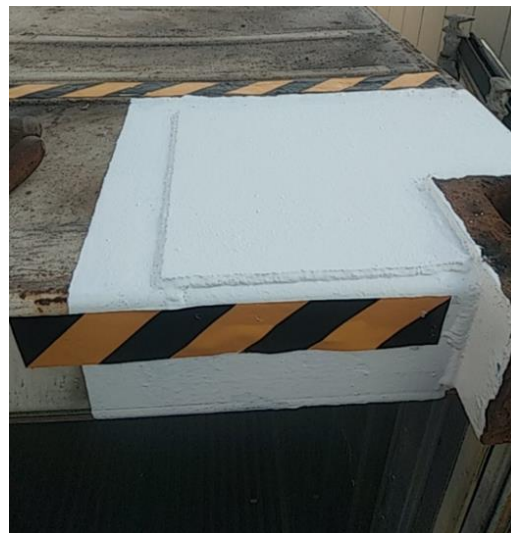
Proper replacement of the Corner Protection Plate below the upper face of the top corner fittings after inserting rear header.

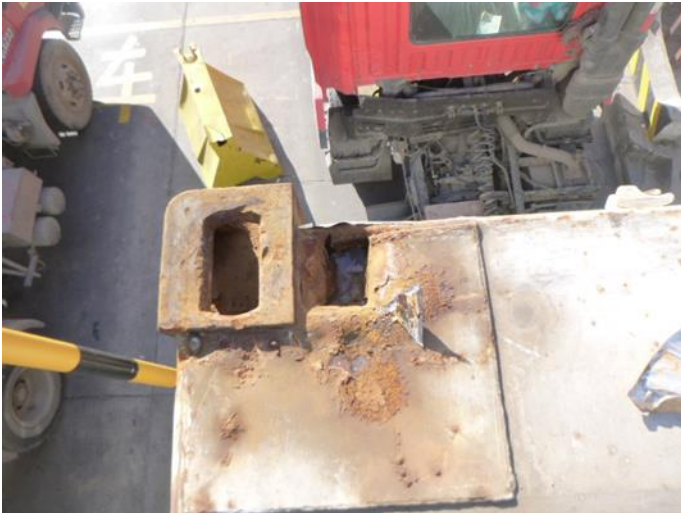
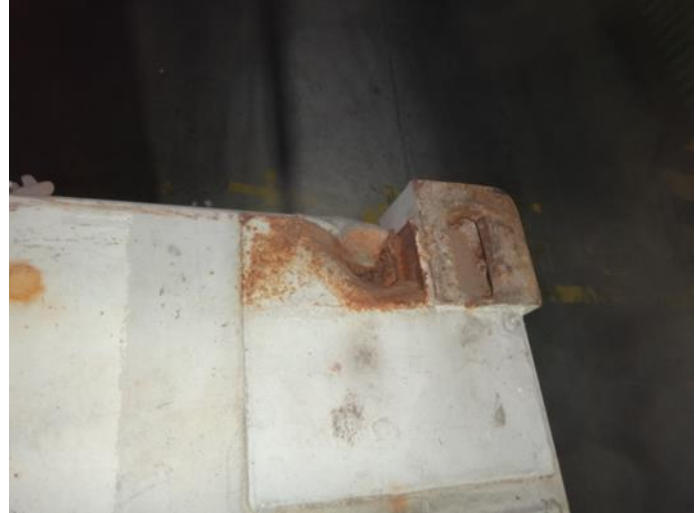
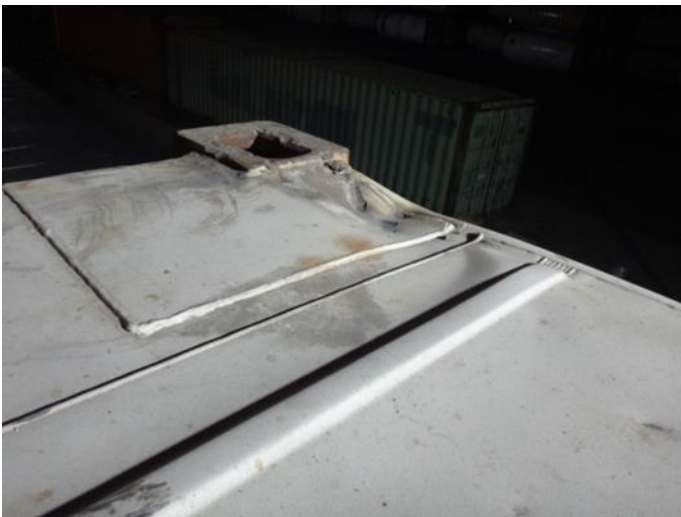
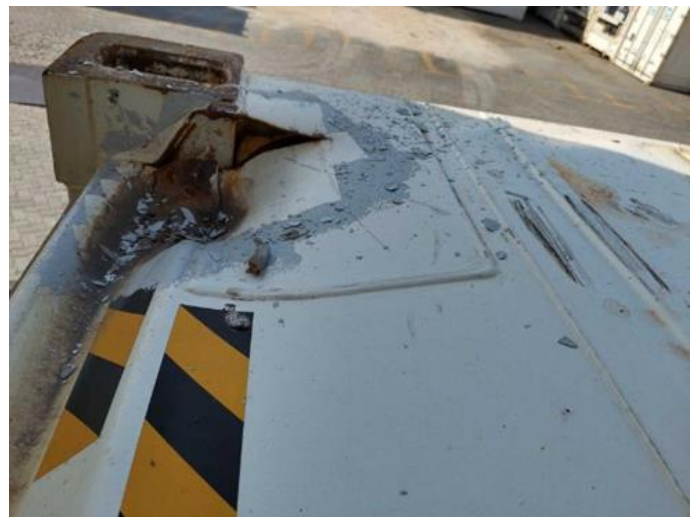
Above photos show different damage conditions to Corner Protection Plates, Extension Plates, top Side Rails and Headers. Often these damages are caused by twist locks during loading/unloading operations despite the existence of reinforcements. To avoid extensive water damage to the insulation, damages breaching the external cladding should be repaired as soon as possible.

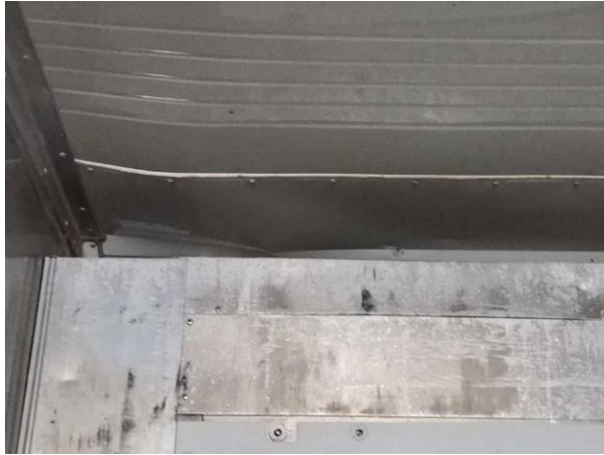
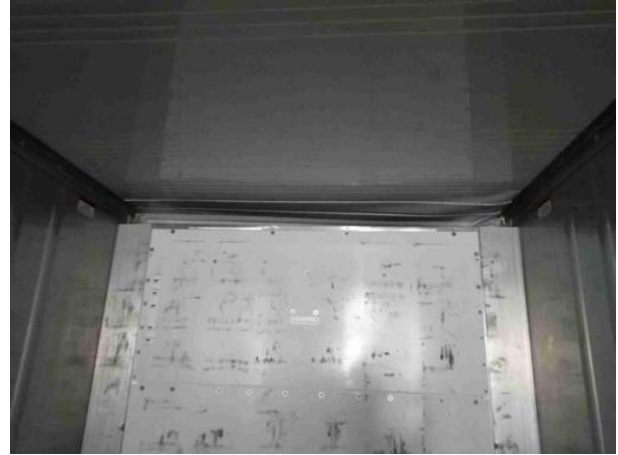
Damages to Corner protection Plates and Extension Plates frequently impact the interior of refrigerated containers. Careful inspection is important to determine need for repairs on consequential damages.

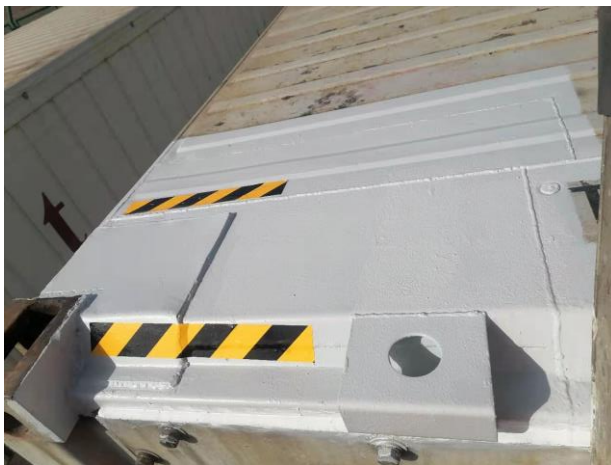
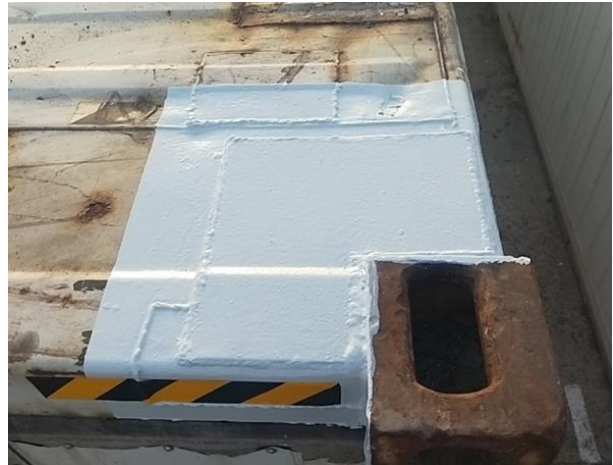
Proper repairs performed on Corner Protection Plates after repairing damaged Extension Plate and / or Header.

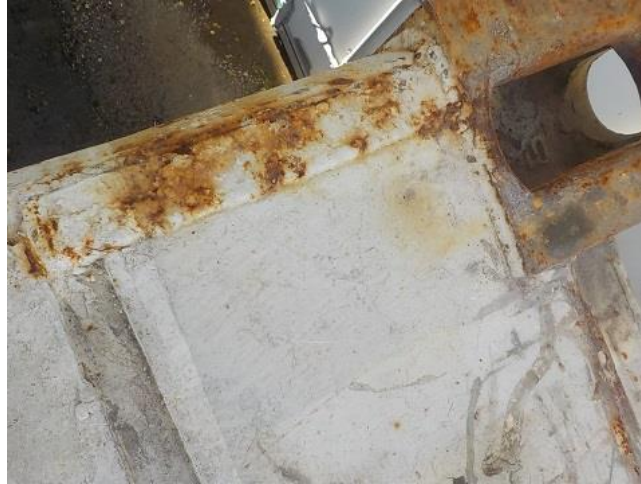
Non-conforming repair. Damage to Corner protection Plate and Top Side Rail patched over. The size of the patch exceeds the size of the original corner protection plate and the top side rail was not repaired prior to installation of the patch. Rework required.

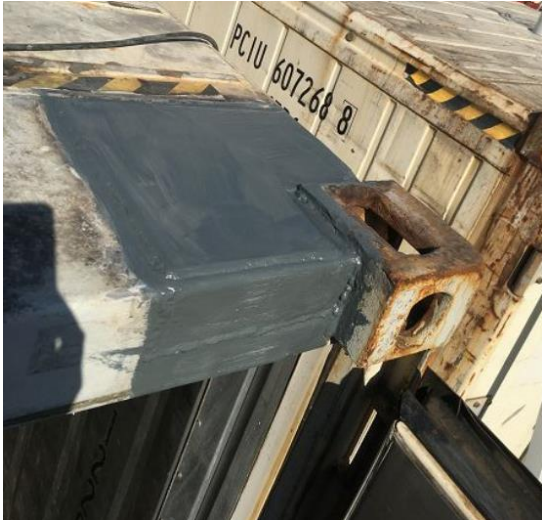
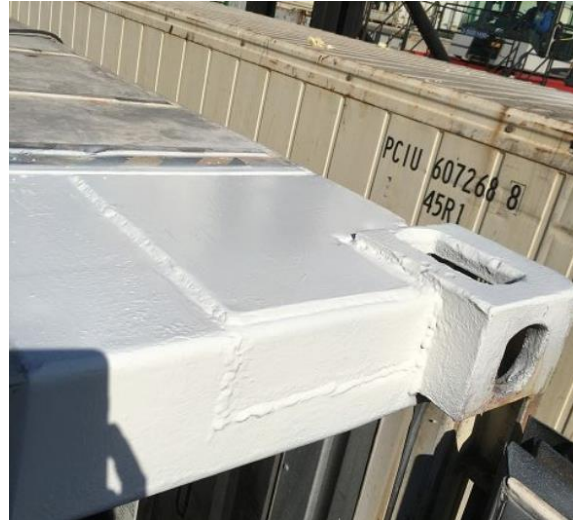
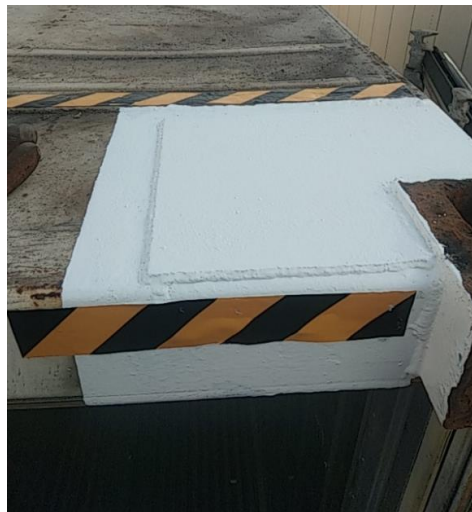
Rear Header and Corner Protection Plate repair sequence.
