August 26, 2020

EVALUATION OF TWO COATING SYSTEMS FOR REFRIGERATED SHIPPING CONTAINERS

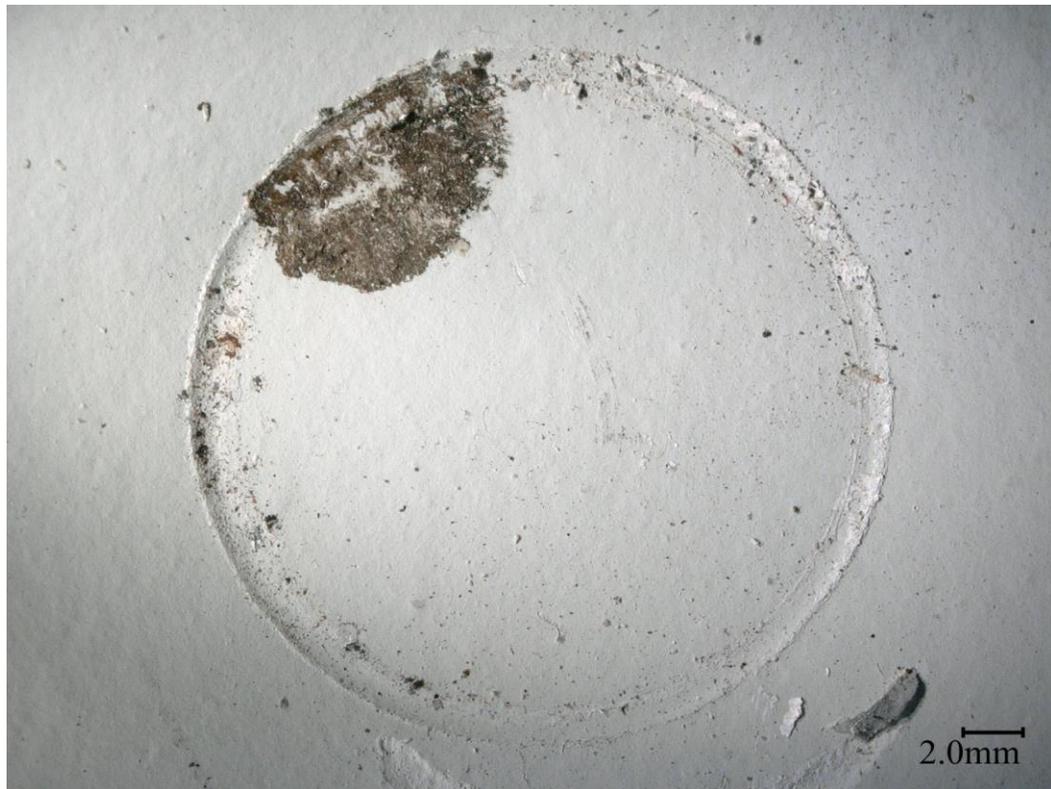
(a) Sample A 10X

(b) Sample A, Box in (a) 50X

Figure 3 Digital microscope images of Sample A after an impact test.

Samples A and E were impact tested, then salt spray tested per ASTM B117 for 500 hours. The impact test consisted of placing the samples coating side up on a support base at the bottom of a vertical ten-foot guide tube and then a 17-pound weight was dropped through the guide tube. Digital images of the surface condition of Samples A and E after the impact test and before the salt spray test are shown in Figure 3 – Figure 4. A photograph of the samples after a salt spray test is shown in Figure 7 and digital images are shown in Figure 8 – Figure 9. The results are summarized in Table 2. Samples A and E did not exhibit de-bonding of the coating at the impact point or cracks in the coating at the indentation slope.

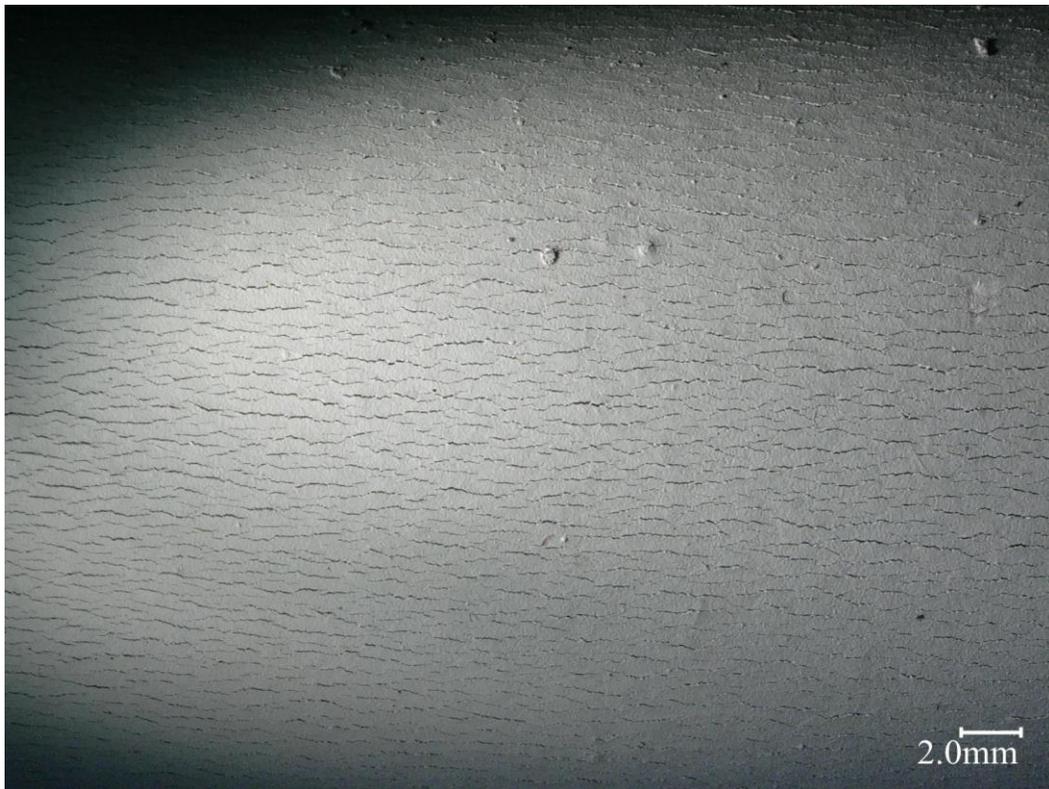
(a) Sample F 10X

(b) Sample F, Box in (a) 50X

Figure 6 Digital microscope images of Sample F after a bend test.

Samples B and F were three-point bend tested, then salt spray tested per ASTM B117 for 500 hours. Both coupons were placed coating-side down for the bend test. Digital images of the surface condition of Samples B and G after the bend test, before the salt spray test are shown in Figure 5 – Figure 6. A photograph of the samples after a salt spray test are shown in Figure 10 and digital images are shown in Figure 11 – Figure 12. The results are summarized in Table 3. Samples B and G had cracks in the coating at the bend radius.

The HZS + Mid Coating + Top Coating performed very well in every evaluation. In the bend test, both samples, zinc primer (Sample F) and HZS (Sample B), exhibited cracks in the coating at the apex of the bend, shown in Figure 5 and Figure 6. After 500 hours of salt spray, the zinc primer samples exhibited extensive rust scoring 4 out of 10 (Figure 12), while the HZS sample exhibited only a small amount of rust and zinc salting (Figure 11) and scored 9 out of 10 in ASTM D 610 grading scale. The HZS samples performed better in the scribe test (Sample C) except for some very small blisters that were found adjacent to the scribe line after 500 hours of salt spray resulting in an ASTM D 714 blister rating of 8 and an ASTM D 1654 scribe rating of 9. The Zinc Primer sample (Sample G) was found to have bleeding corrosion and undercutting along the complete scribe line after the 500 hours of salt spray which resulted in an ASTM D 714 blister rating of 8 and an ASTM D 1654 scribe rating of 8.

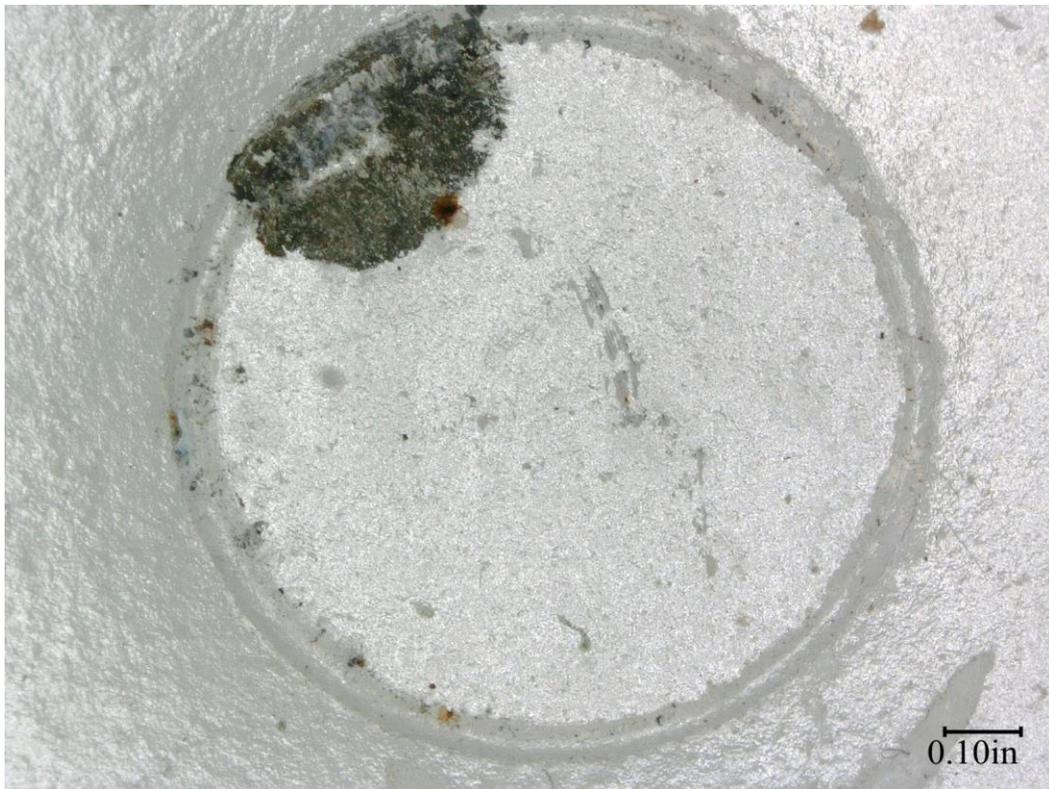
Figure 8 Digital microscope images of Sample A after an impact test and salt spray.

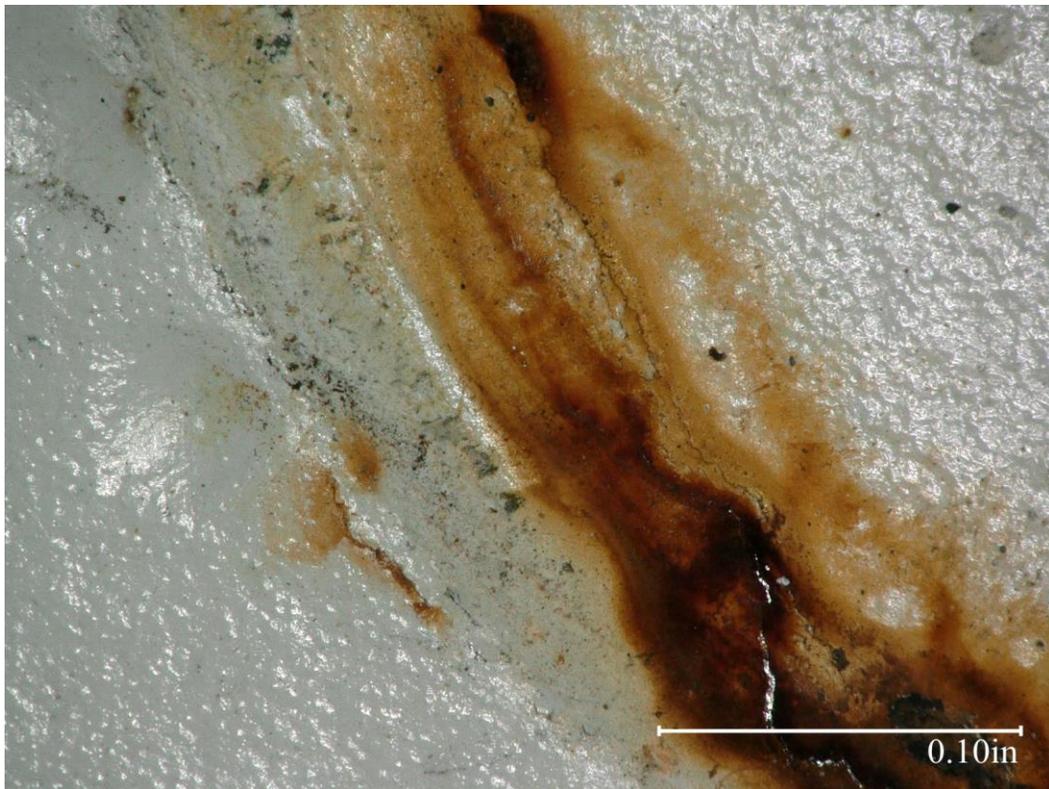
Figure 9 Digital microscope images of Sample E after an impact test and salt spray.

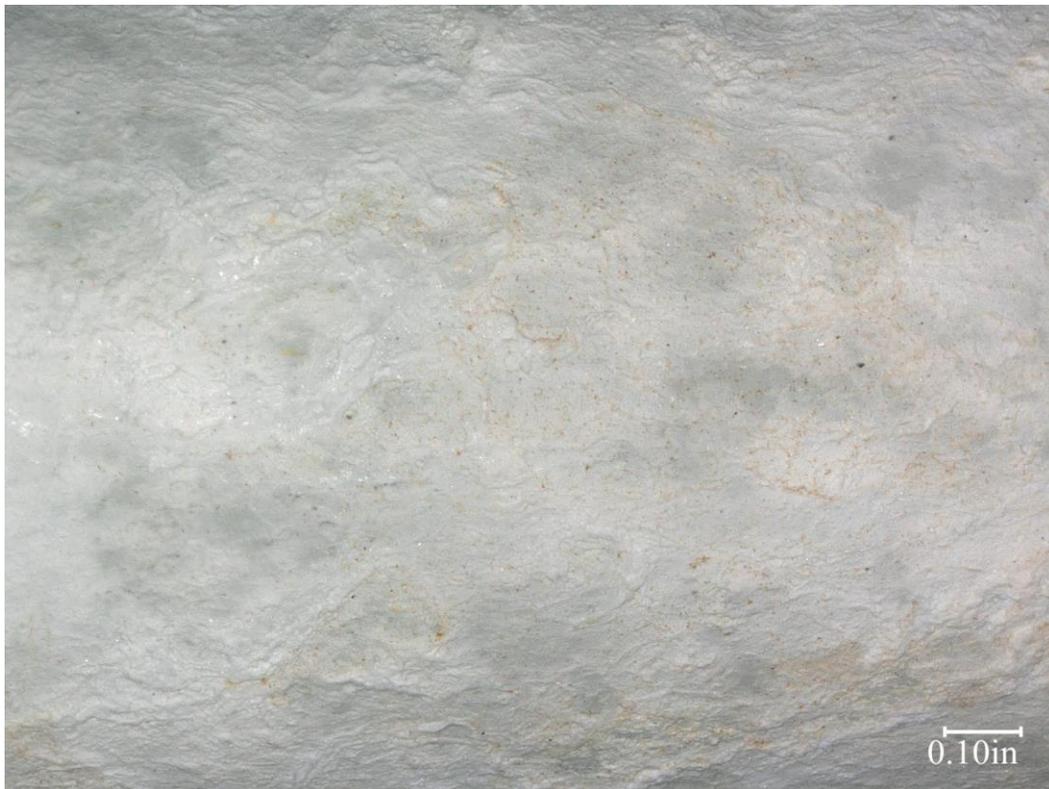
Figure 11 Digital microscope images of Sample B after a bend test and salt spray.

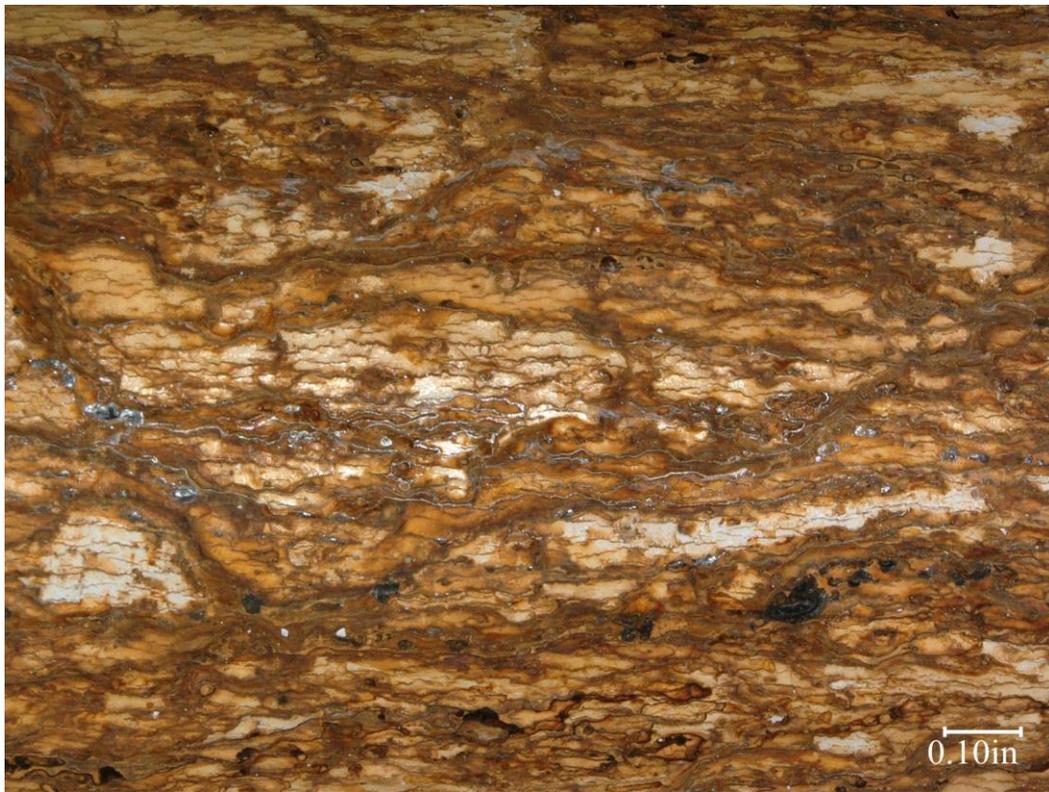
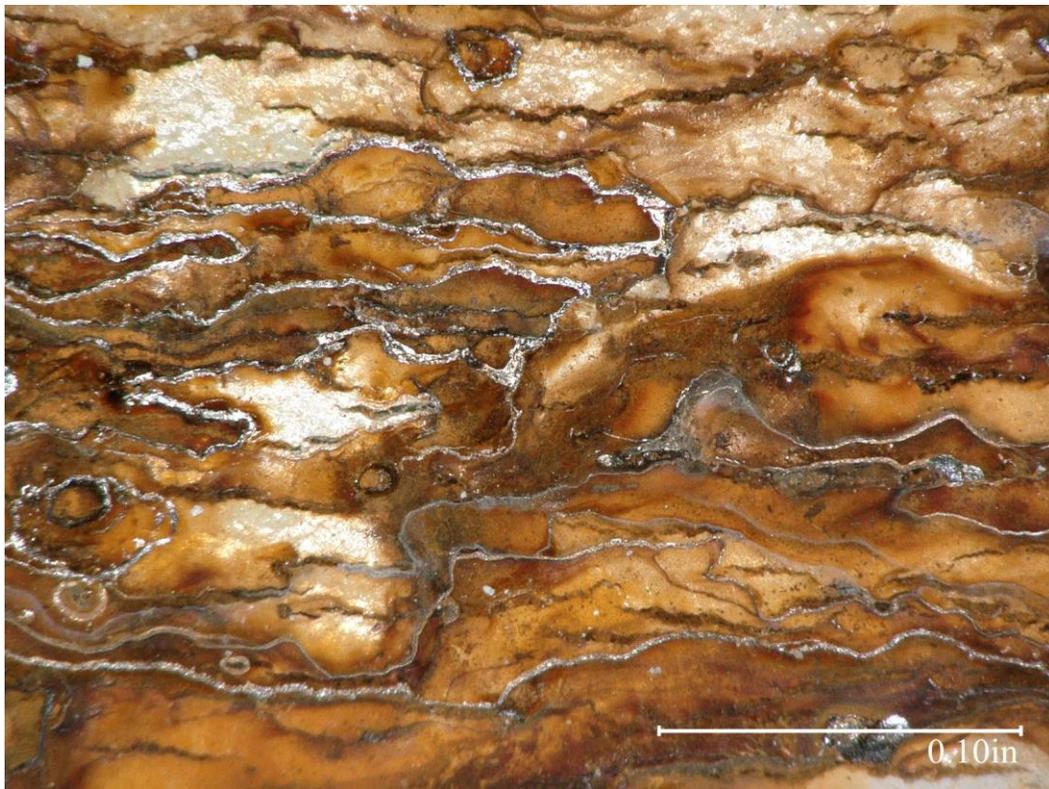
Figure 12 Digital microscope images of Sample F after a bend test and salt spray.

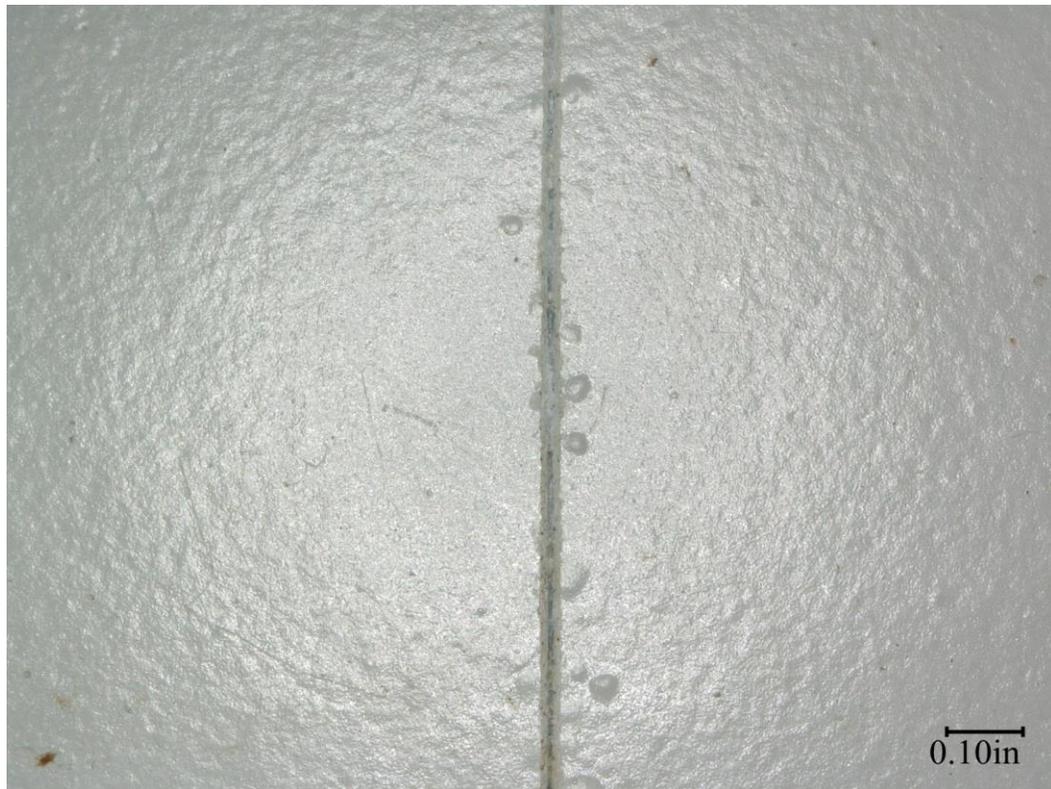
Figure 14 Digital microscope images of Sample C after a scribe and salt spray.

Samples C and G were scribed per ASTM D1654, then salt spray tested per ASTM B117 for 500 hours. The results are summarized in Table 4. A photograph of the surface condition of Samples C and G after the scribe and salt spray is shown in Figure 13 and digital images are shown in Figure 14 – Figure 15.

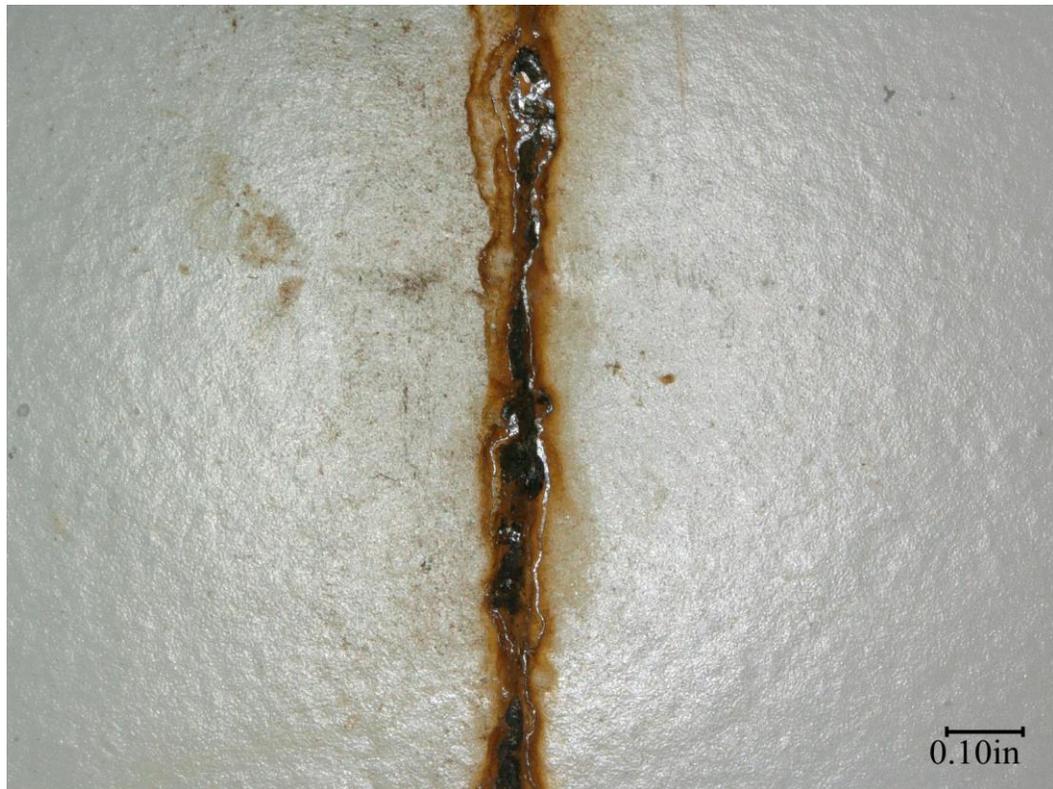
Figure 15 Digital microscope images of Sample G after a scribe and salt spray.
